# '08 Titanium 25E30 Bedroom Remodel

by Tony Ellsworth

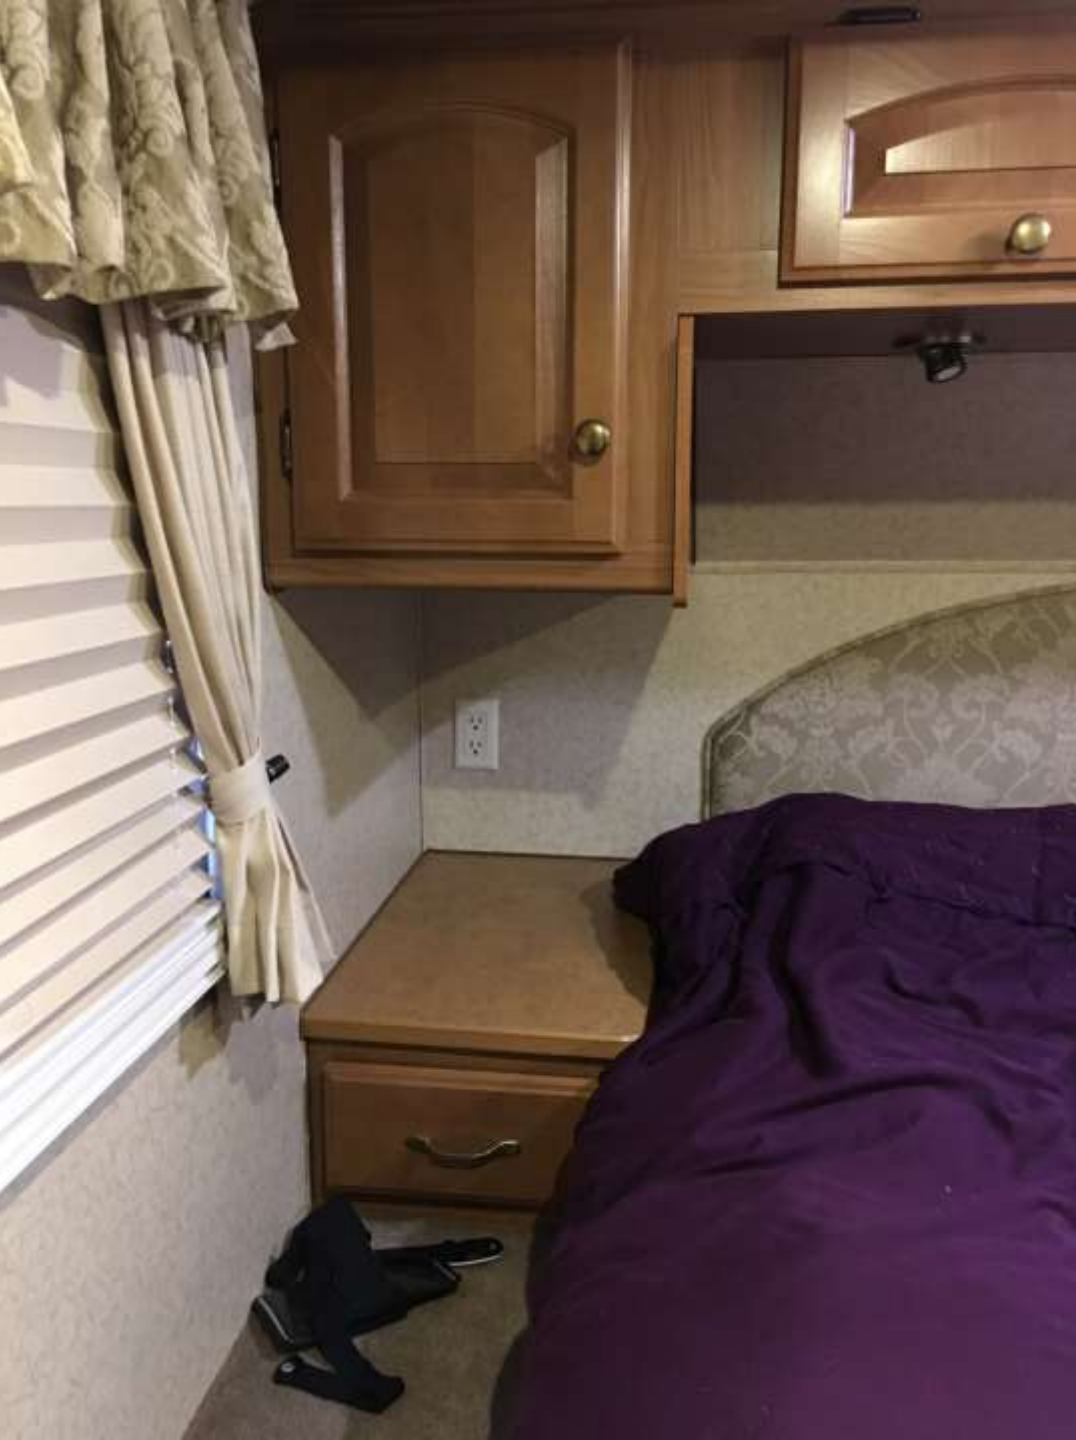
The space above the drawer was totally wasted space.

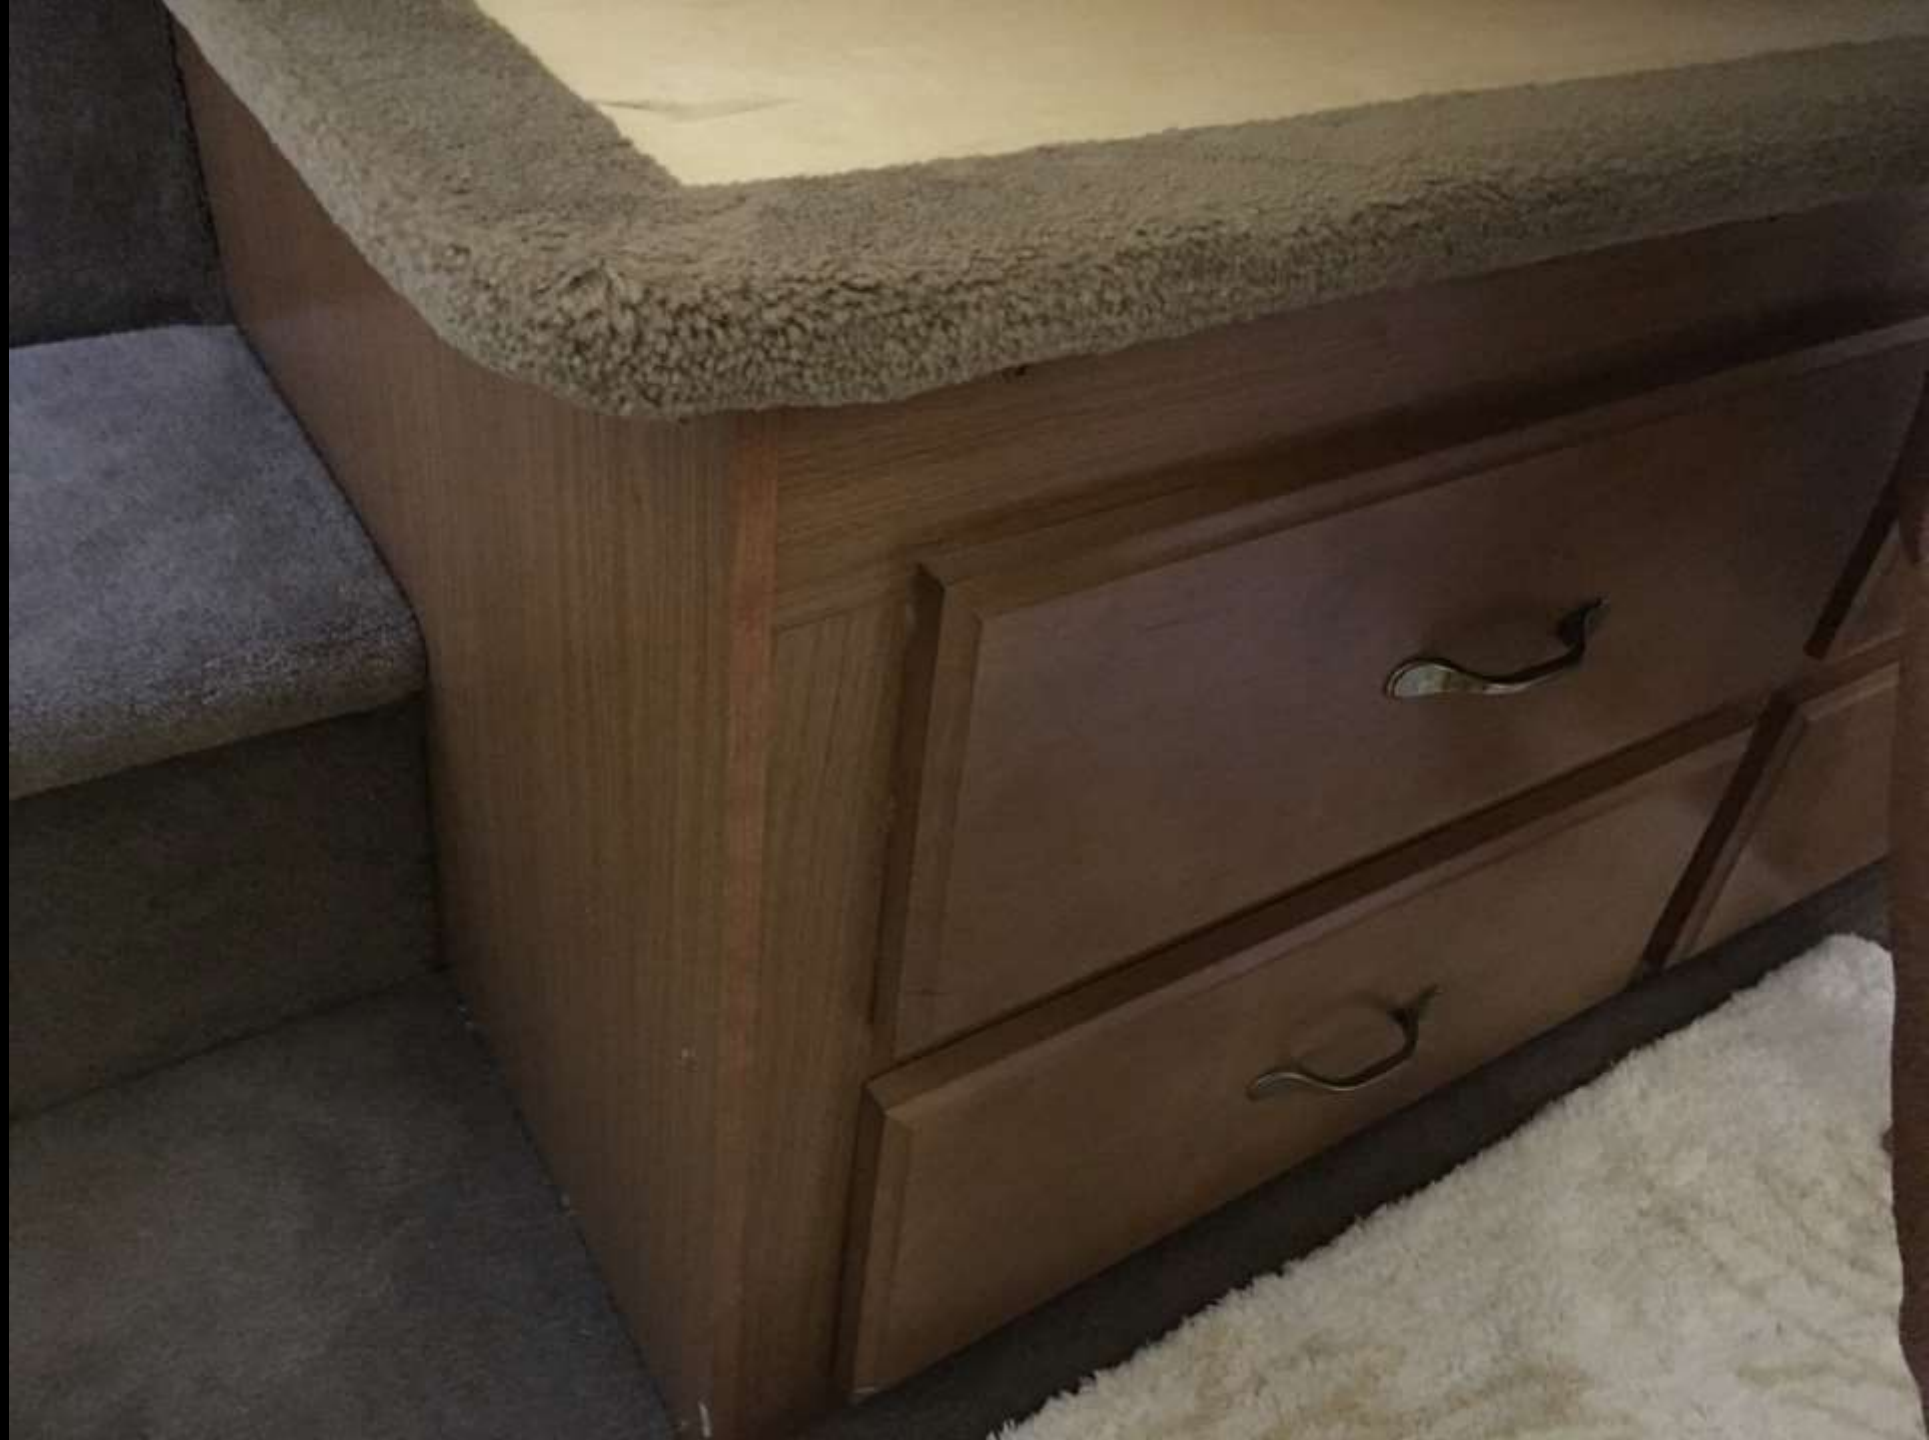
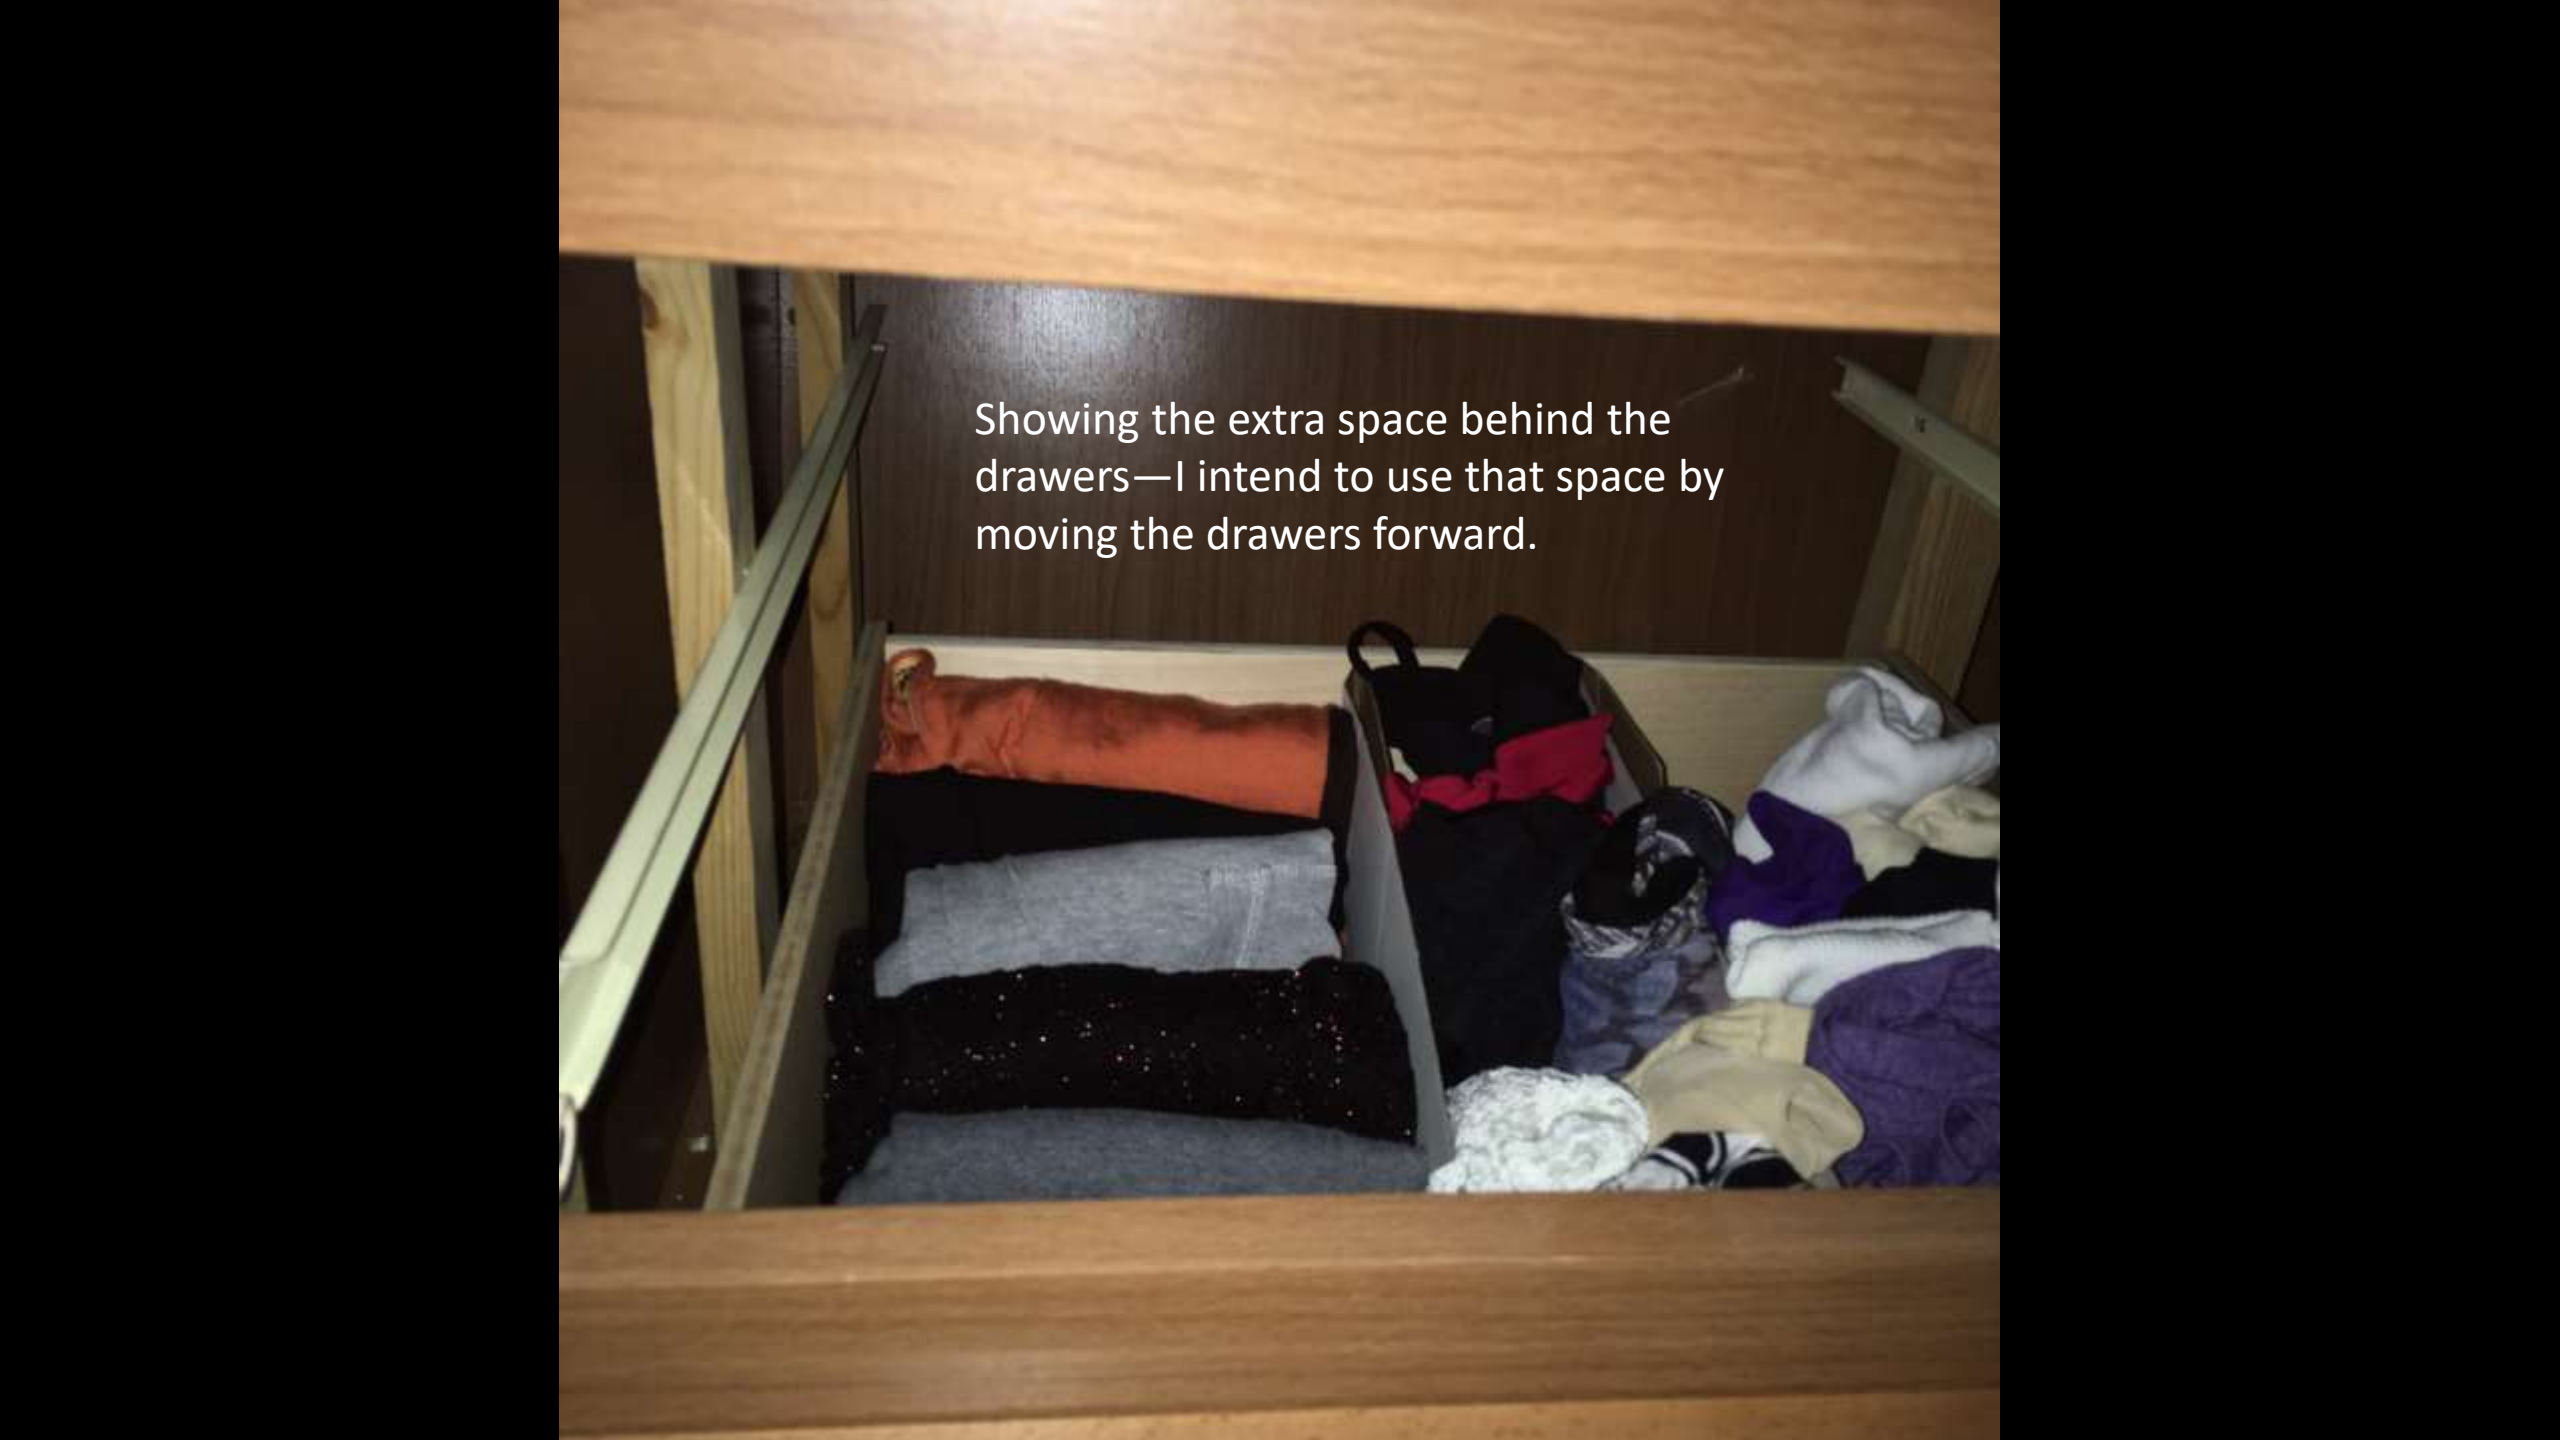
Before, notes the distance from the drawer faces  
To the back of the cabinet... there's 7" in there of  
Unused space...see next pictures.

A photograph showing the interior of a wooden cabinet. A drawer is pulled out, revealing various items of clothing: a long orange sleeve, a black garment, a grey t-shirt, and a black sequined top. To the right of the drawer, there is a pile of folded clothes in purple, white, and yellow. The space behind the drawer is visible, showing a dark wood panel and a gap between the drawer and the cabinet wall. The text is overlaid in the center of the image.

Showing the extra space behind the drawers—I intend to use that space by moving the drawers forward.

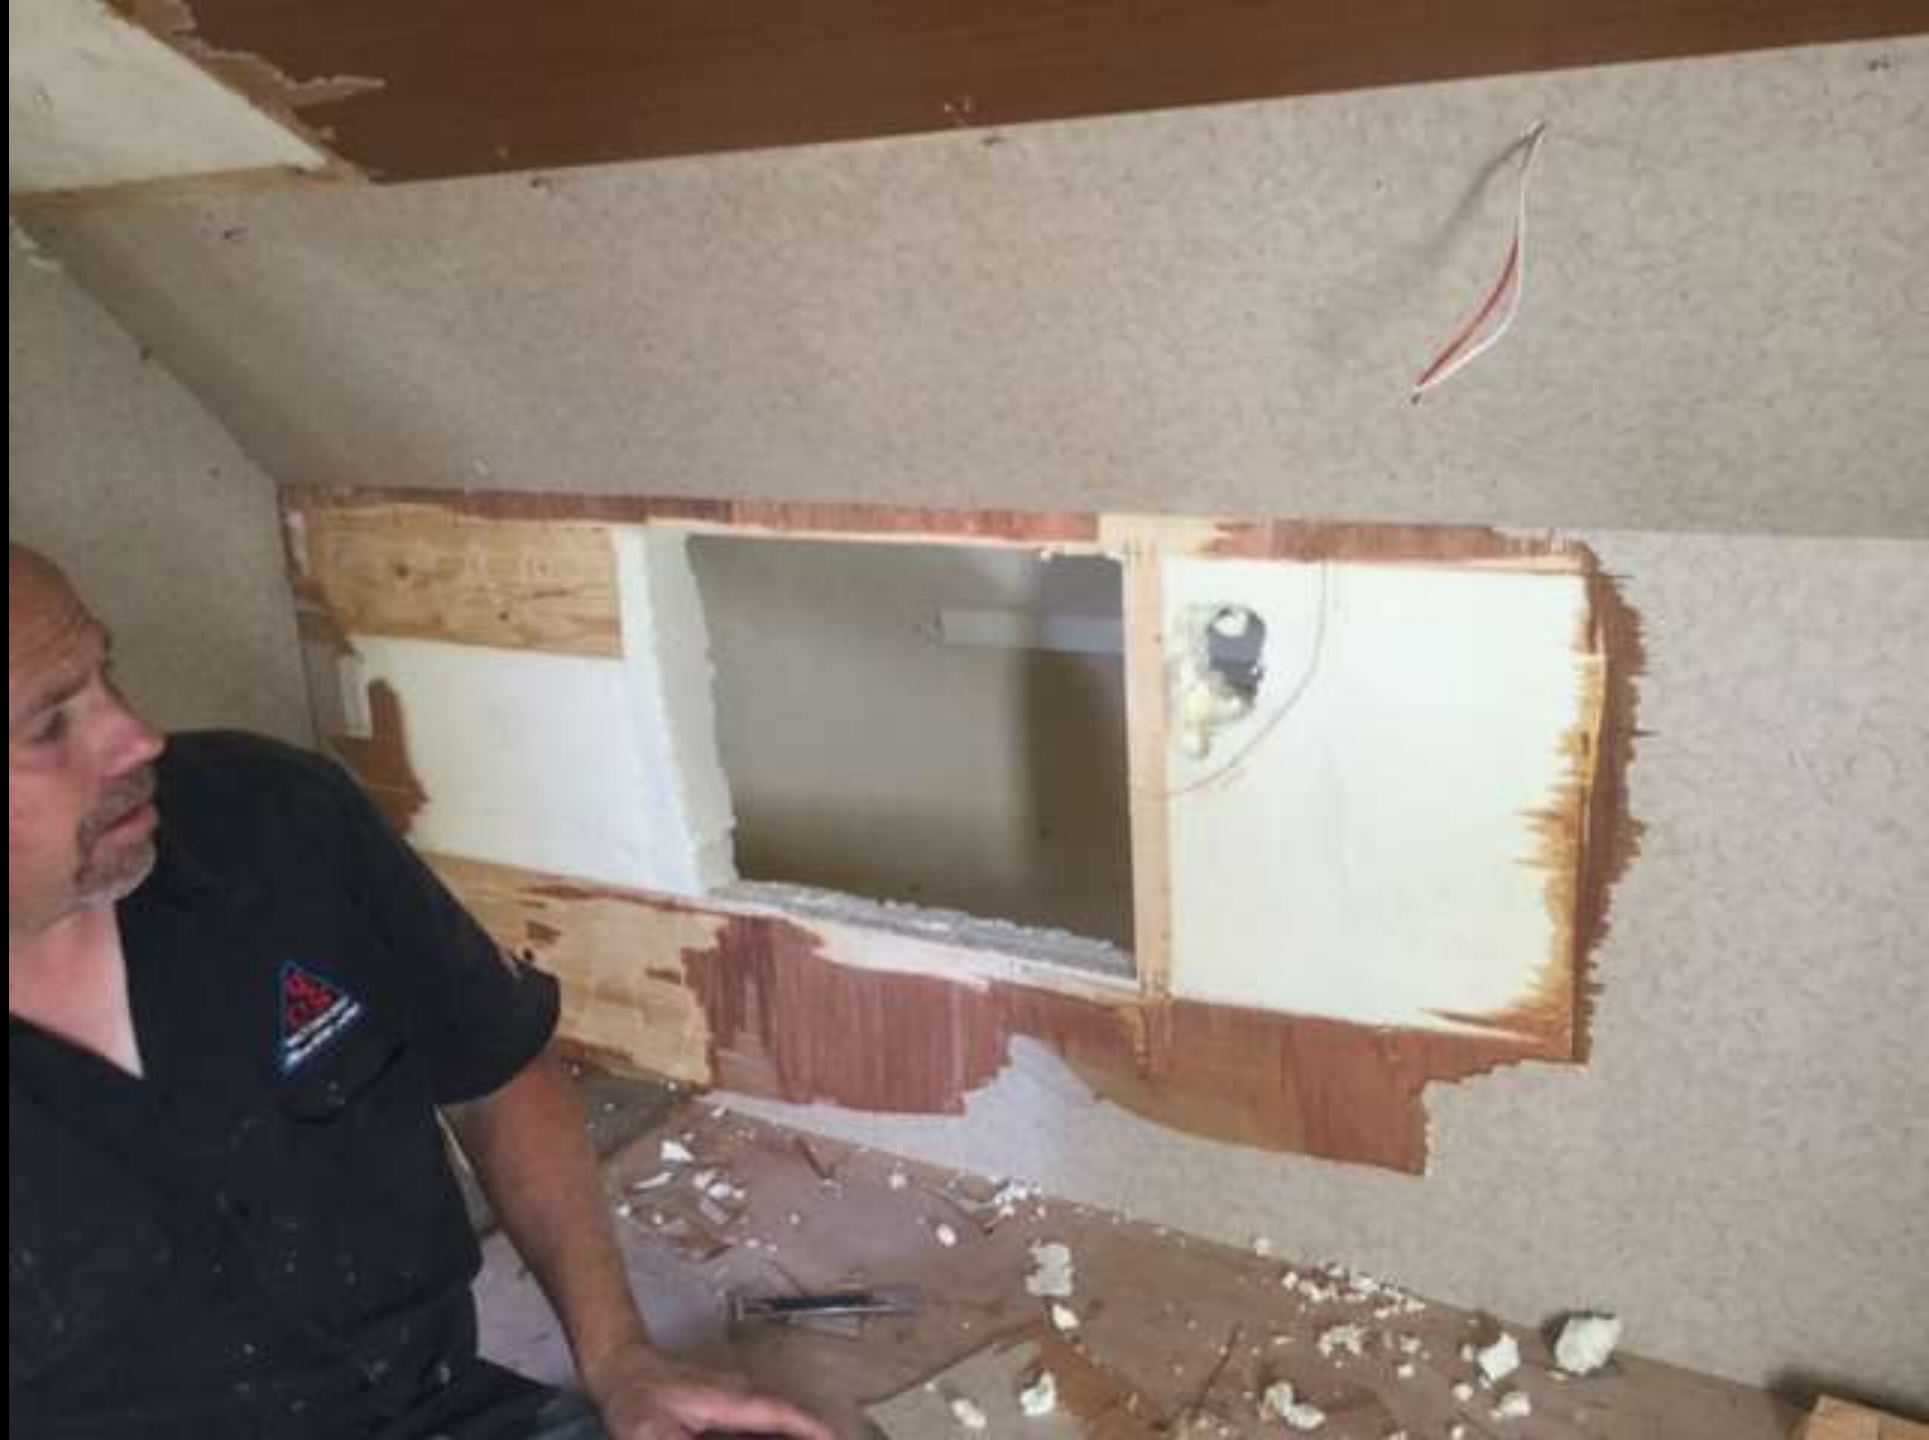
Before they pulled out the existing front.

I had already had the cap off a couple of years before, when I hit something with it and had to repair it while on a road trip—I have a general aversion to the crappy pink stuff that has propagated itself on North America as insulation. So I'd already foamed it with the closed cell foam—which surprised the Quality RV team... But this is what it looked like before the removal of all that. See the wasted space?

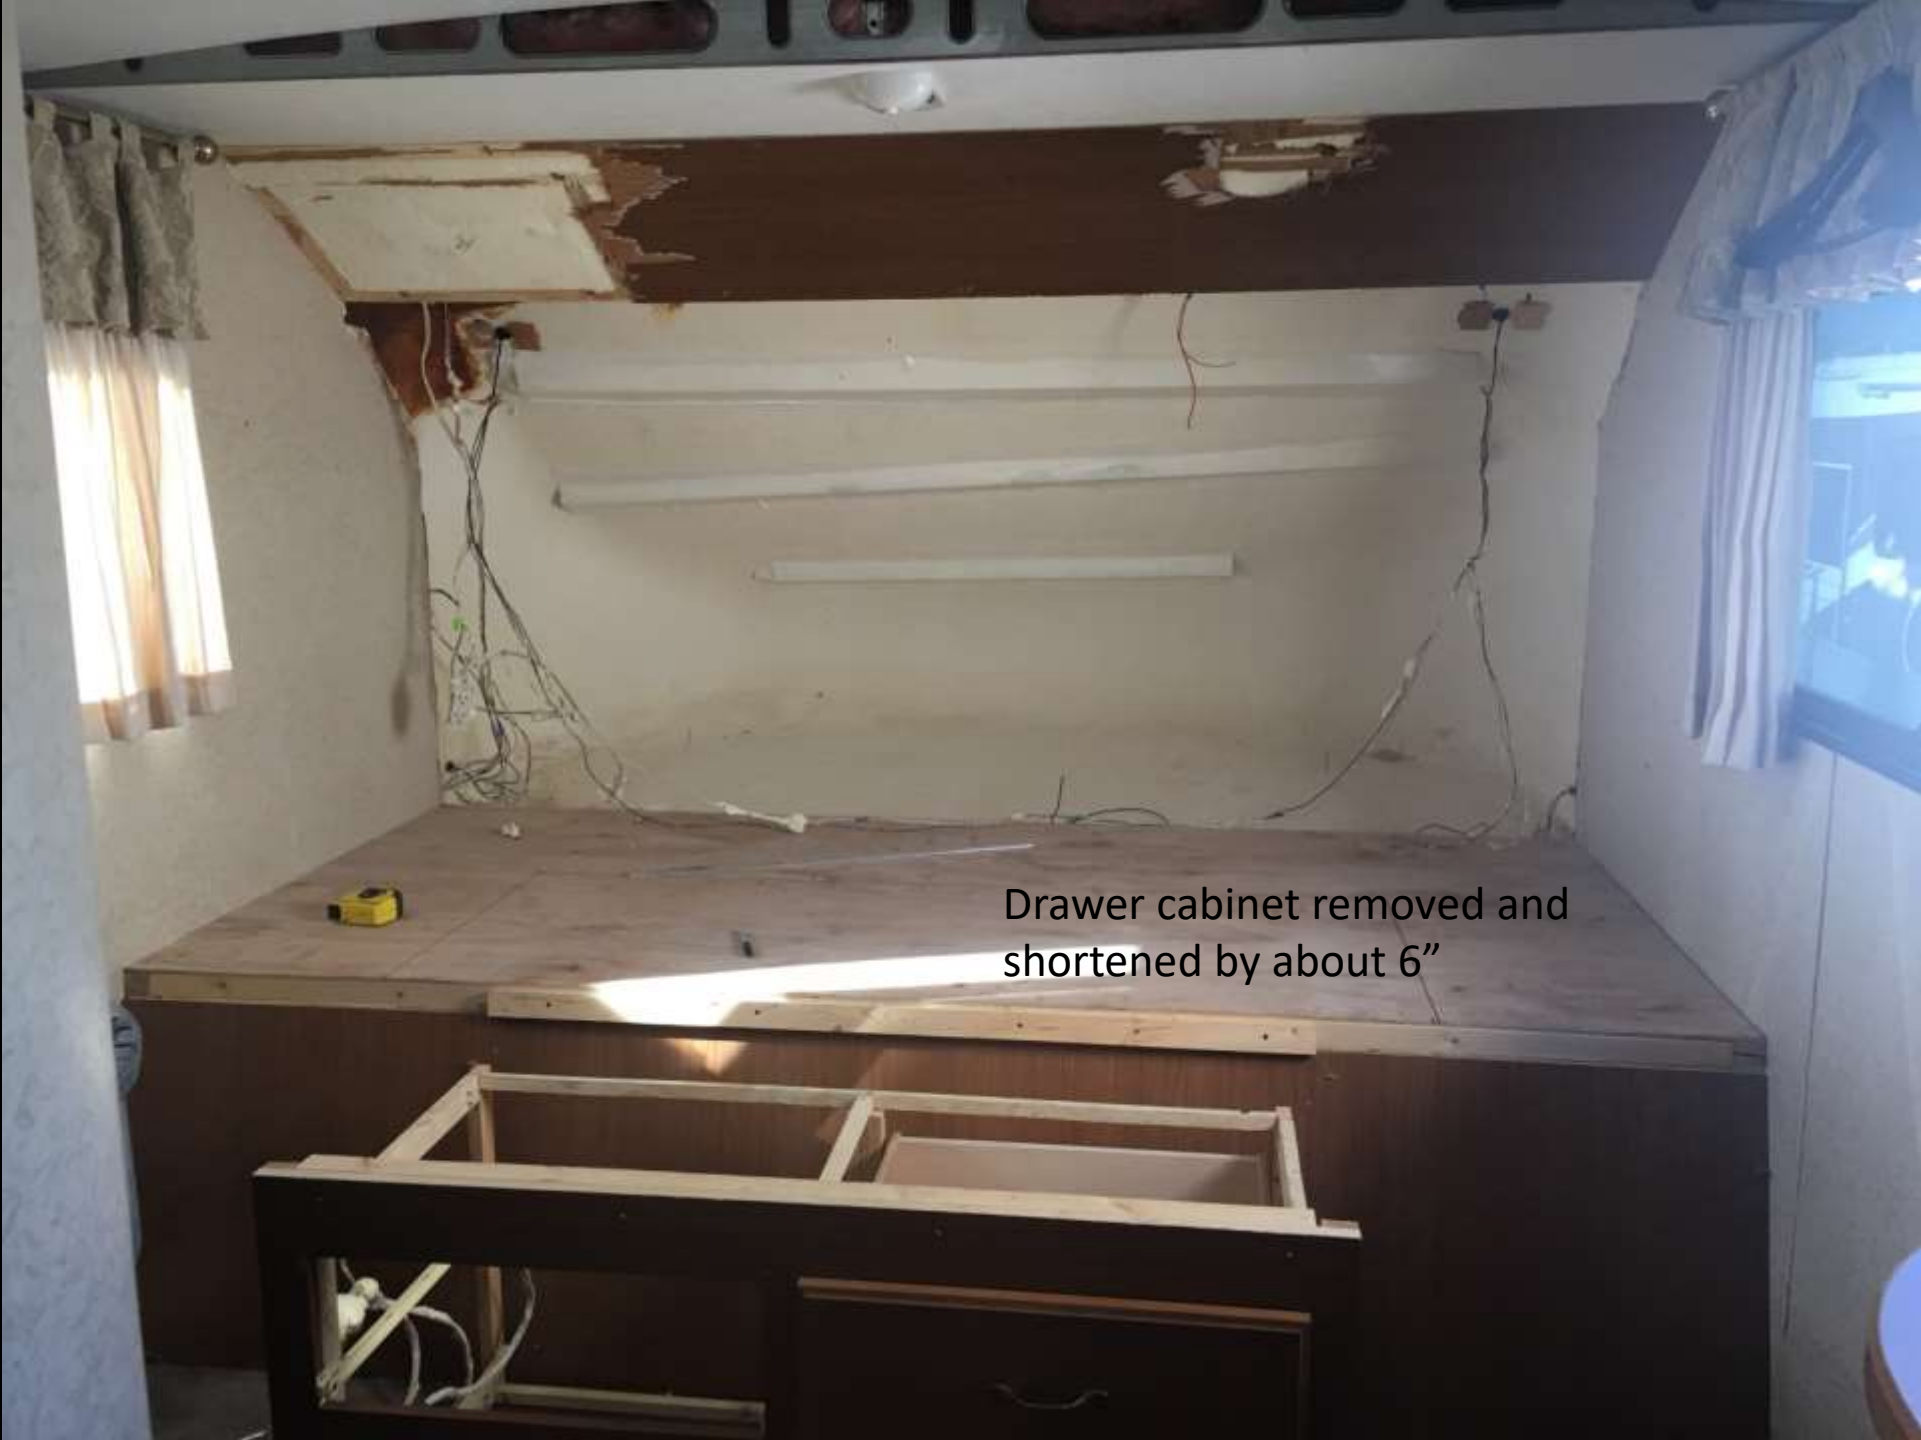
Drawer cabinet removed and shortened by about 6"

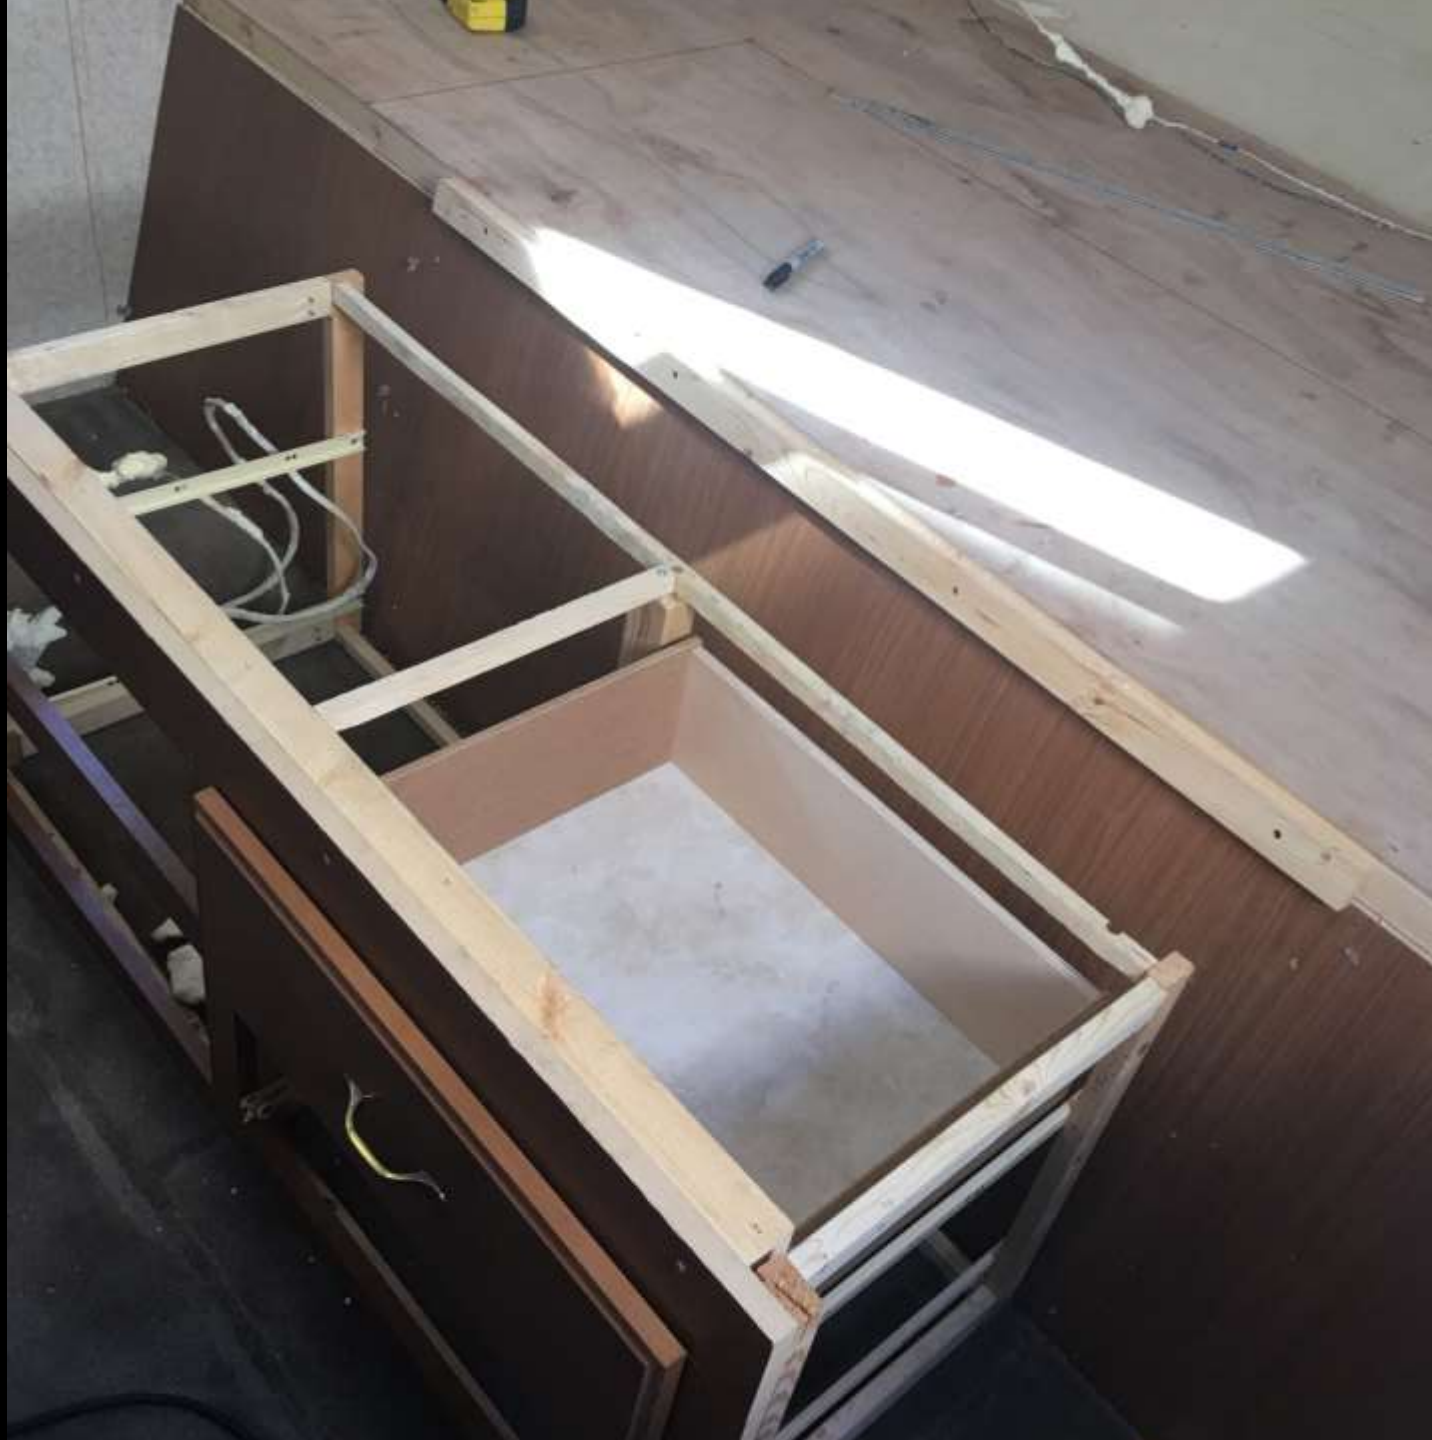
No wasted space  
in front of the  
drawers now!!

You can see by the  
carpet, the  
increased room  
space between  
the bed and the  
entry of the room

See how there's  
no wasted space  
in front of the  
drawers.

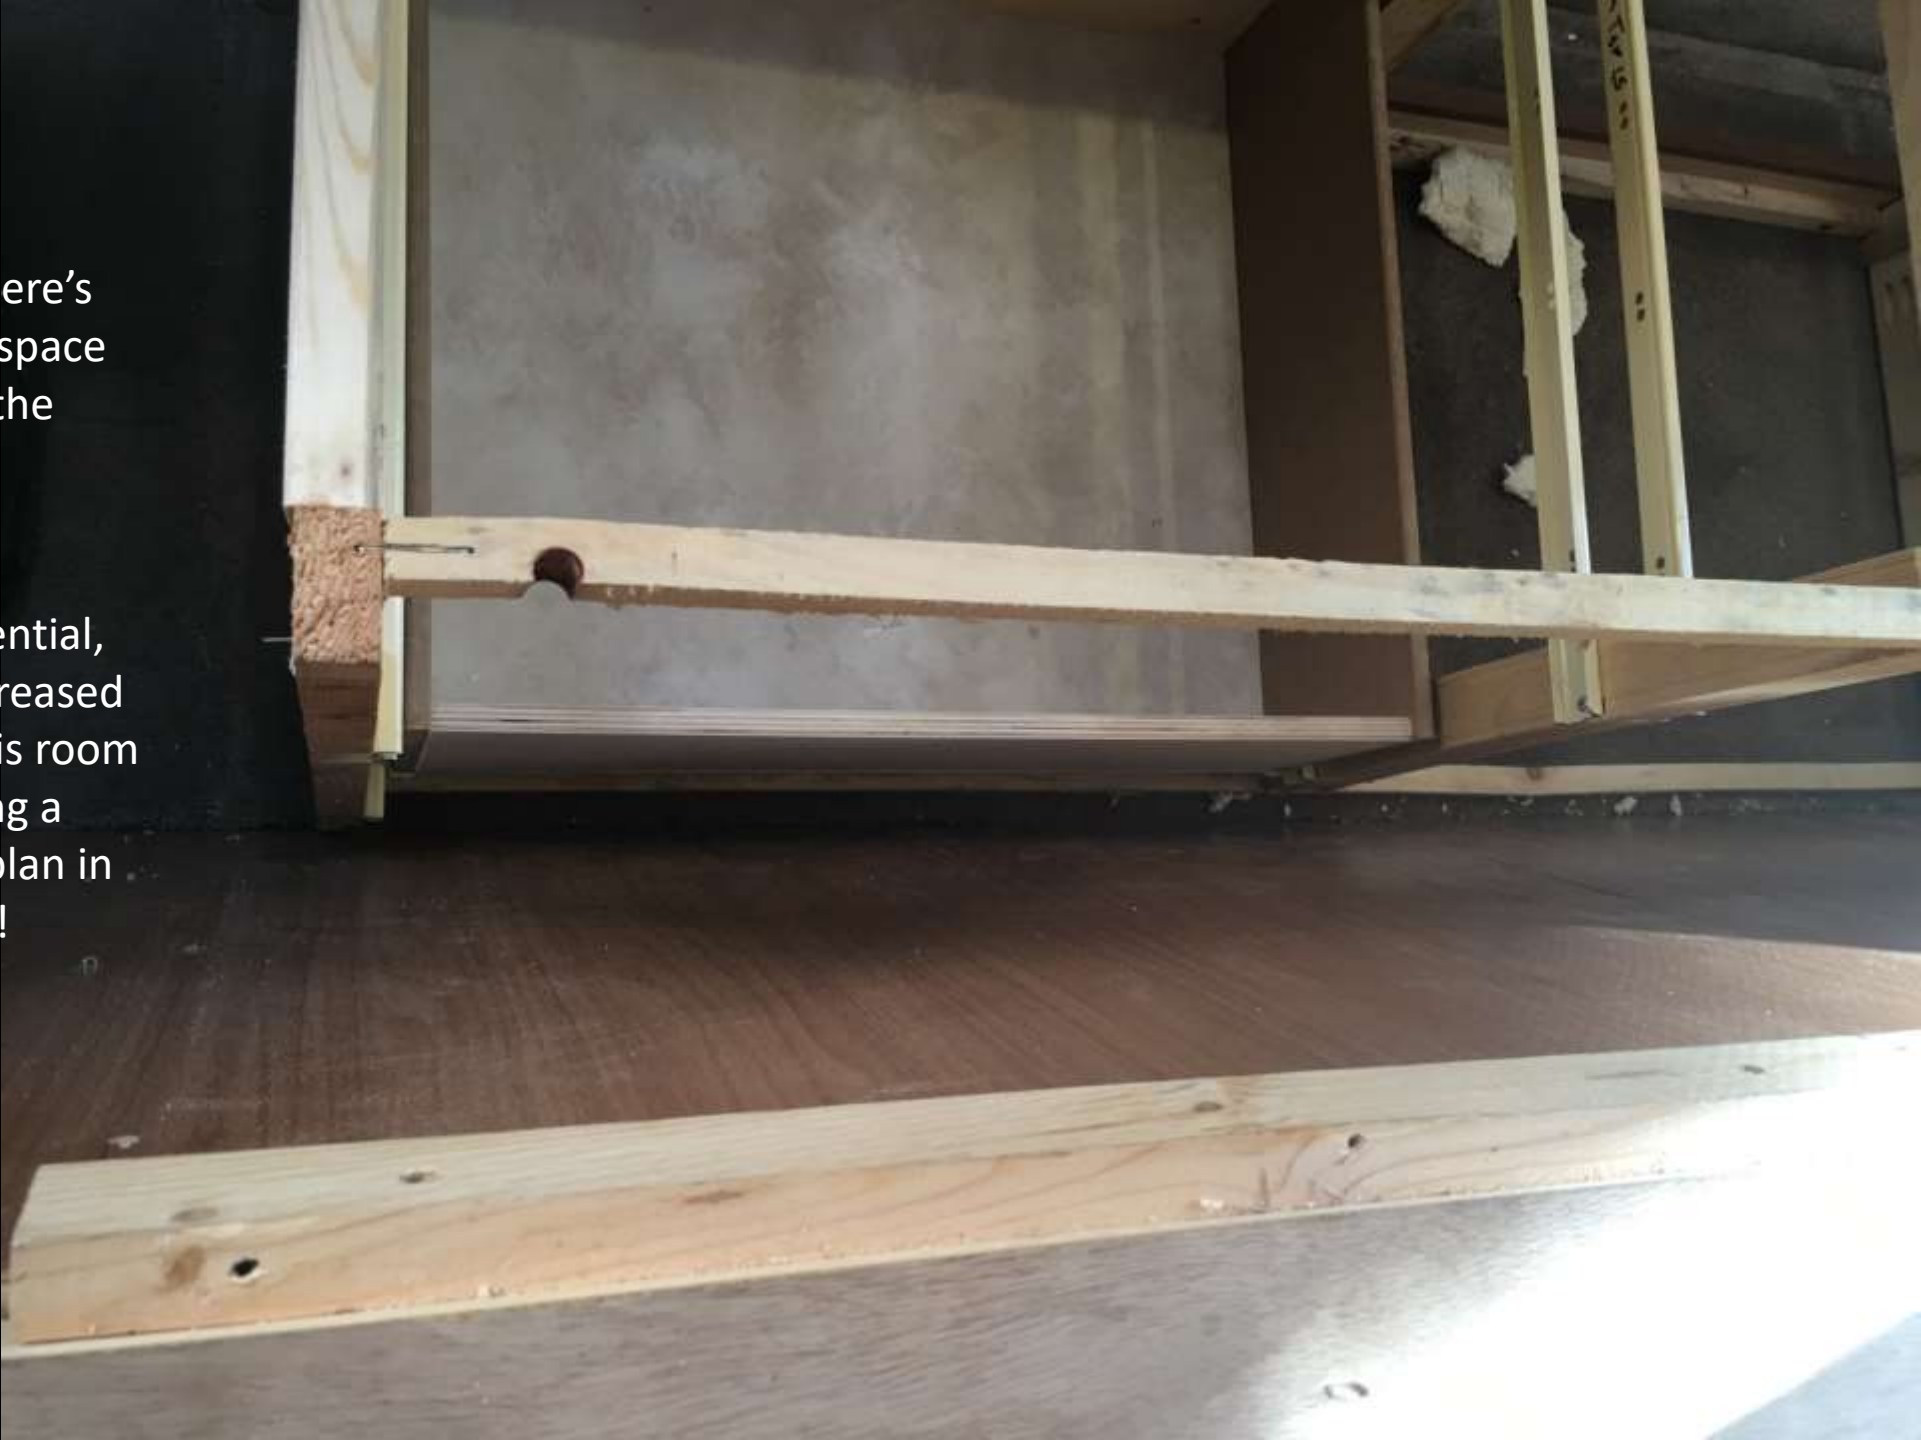
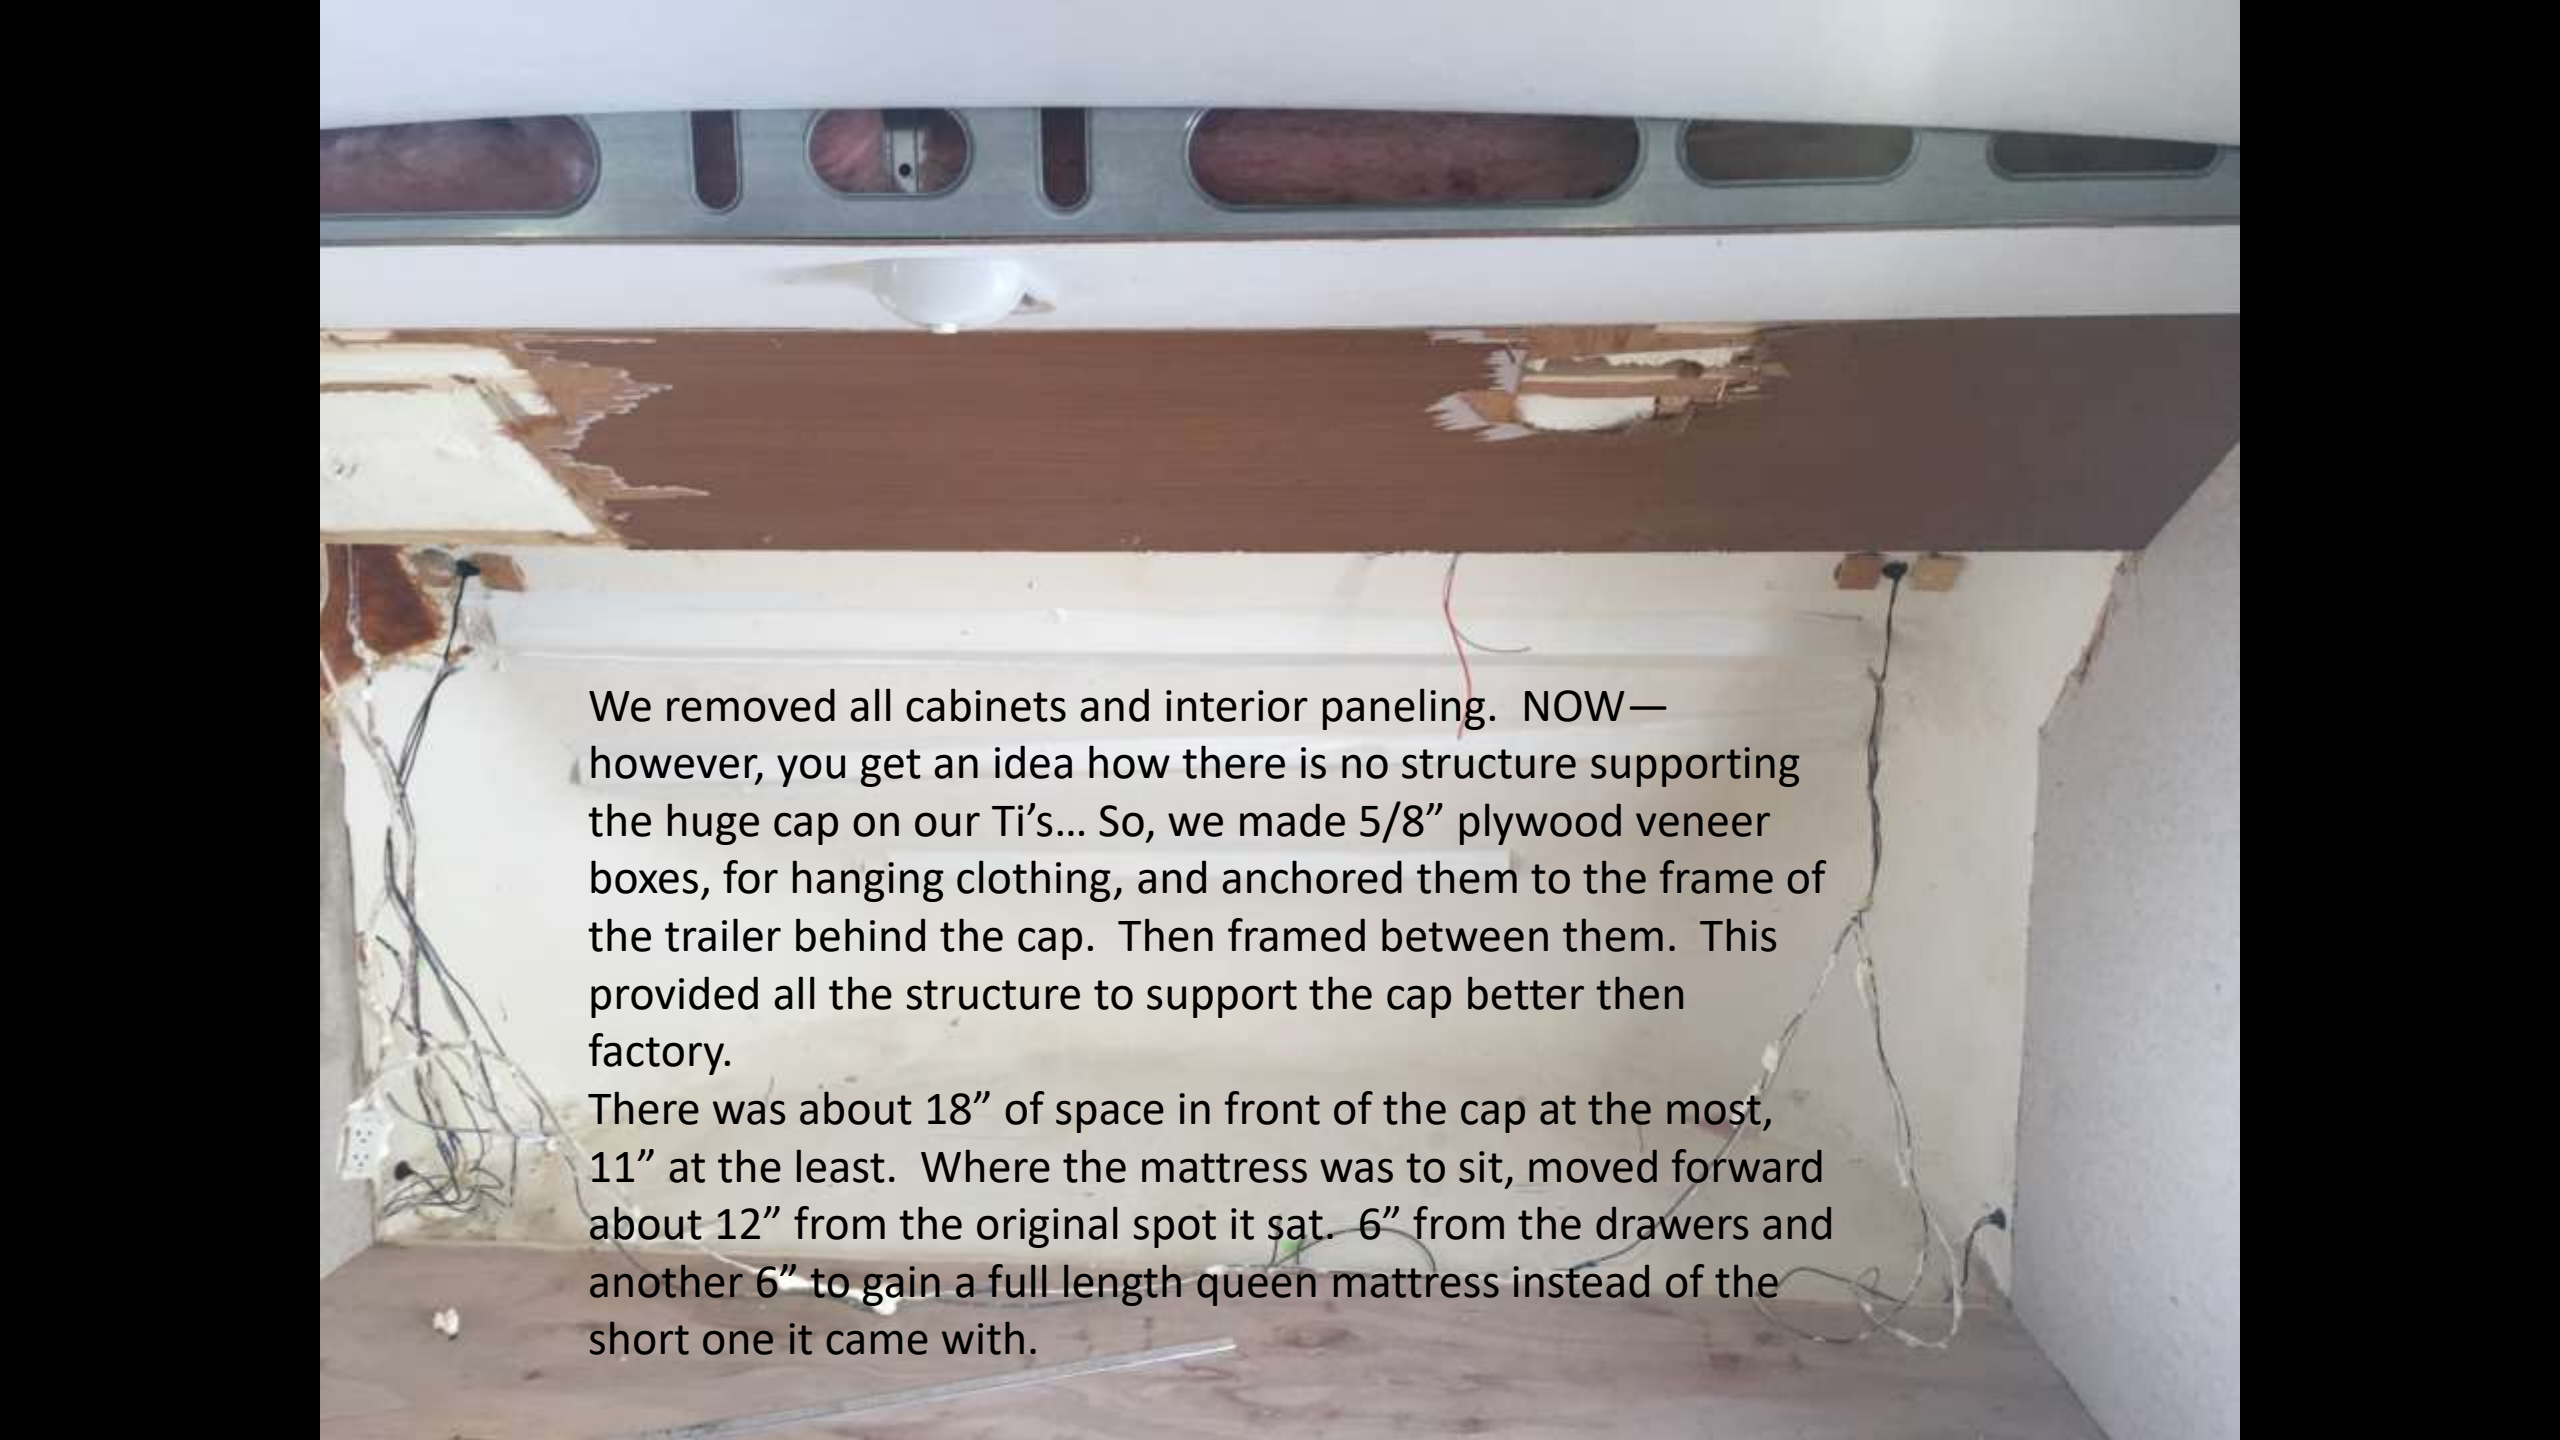
The image shows the interior of a trailer with significant damage to the ceiling. A large section of the brown ceiling panel is missing, revealing the underlying structure and a white light fixture. A metal track with several oval-shaped cutouts is visible at the top. On the left and right sides, there are exposed electrical wires and outlets. The floor is a light-colored, possibly wooden or composite material.

We removed all cabinets and interior paneling. NOW— however, you get an idea how there is no structure supporting the huge cap on our Ti's... So, we made 5/8" plywood veneer boxes, for hanging clothing, and anchored them to the frame of the trailer behind the cap. Then framed between them. This provided all the structure to support the cap better than factory.

There was about 18" of space in front of the cap at the most, 11" at the least. Where the mattress was to sit, moved forward about 12" from the original spot it sat. 6" from the drawers and another 6" to gain a full length queen mattress instead of the short one it came with.

New bed platform  
screwed down,  $\frac{3}{4}$ " ply  
cantilevers over original  
support in trailer frame.

Closed cell foam backed  
with space blanket  
material, provides  
superior reflective, and  
conductive, as well as  
convective insulation over  
stock.

Space blanket back  
assures cap could still be  
removed after closed cell  
foam is applied in the  
framing.

Wired for additional and  
updated charging and  
power in the room.
