# '08 Titanium 25E30 Bedroom Remodel

by Tony Ellsworth

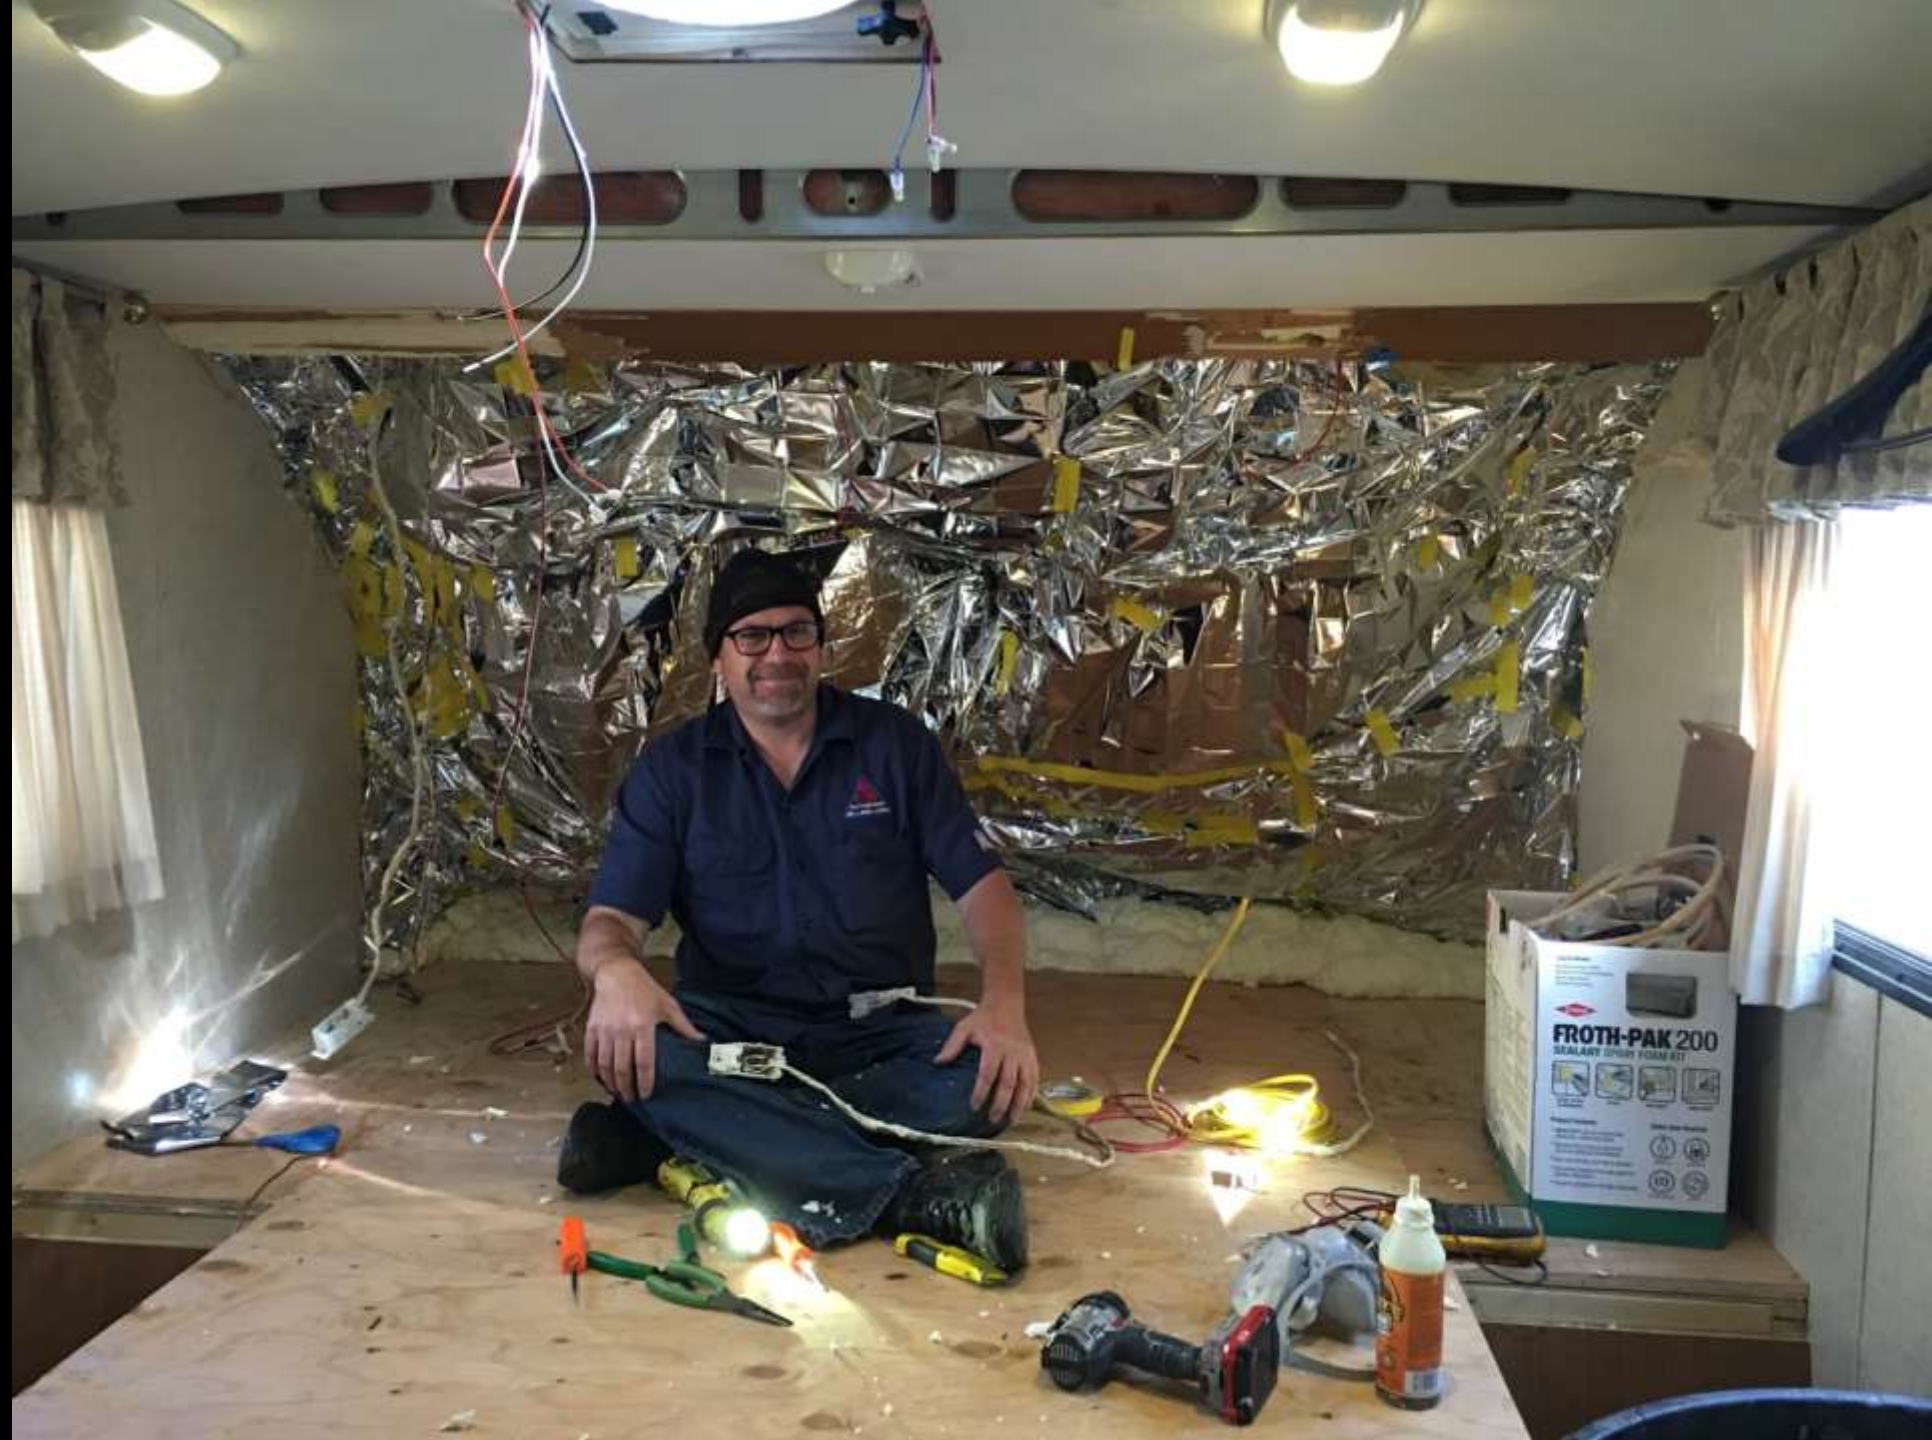
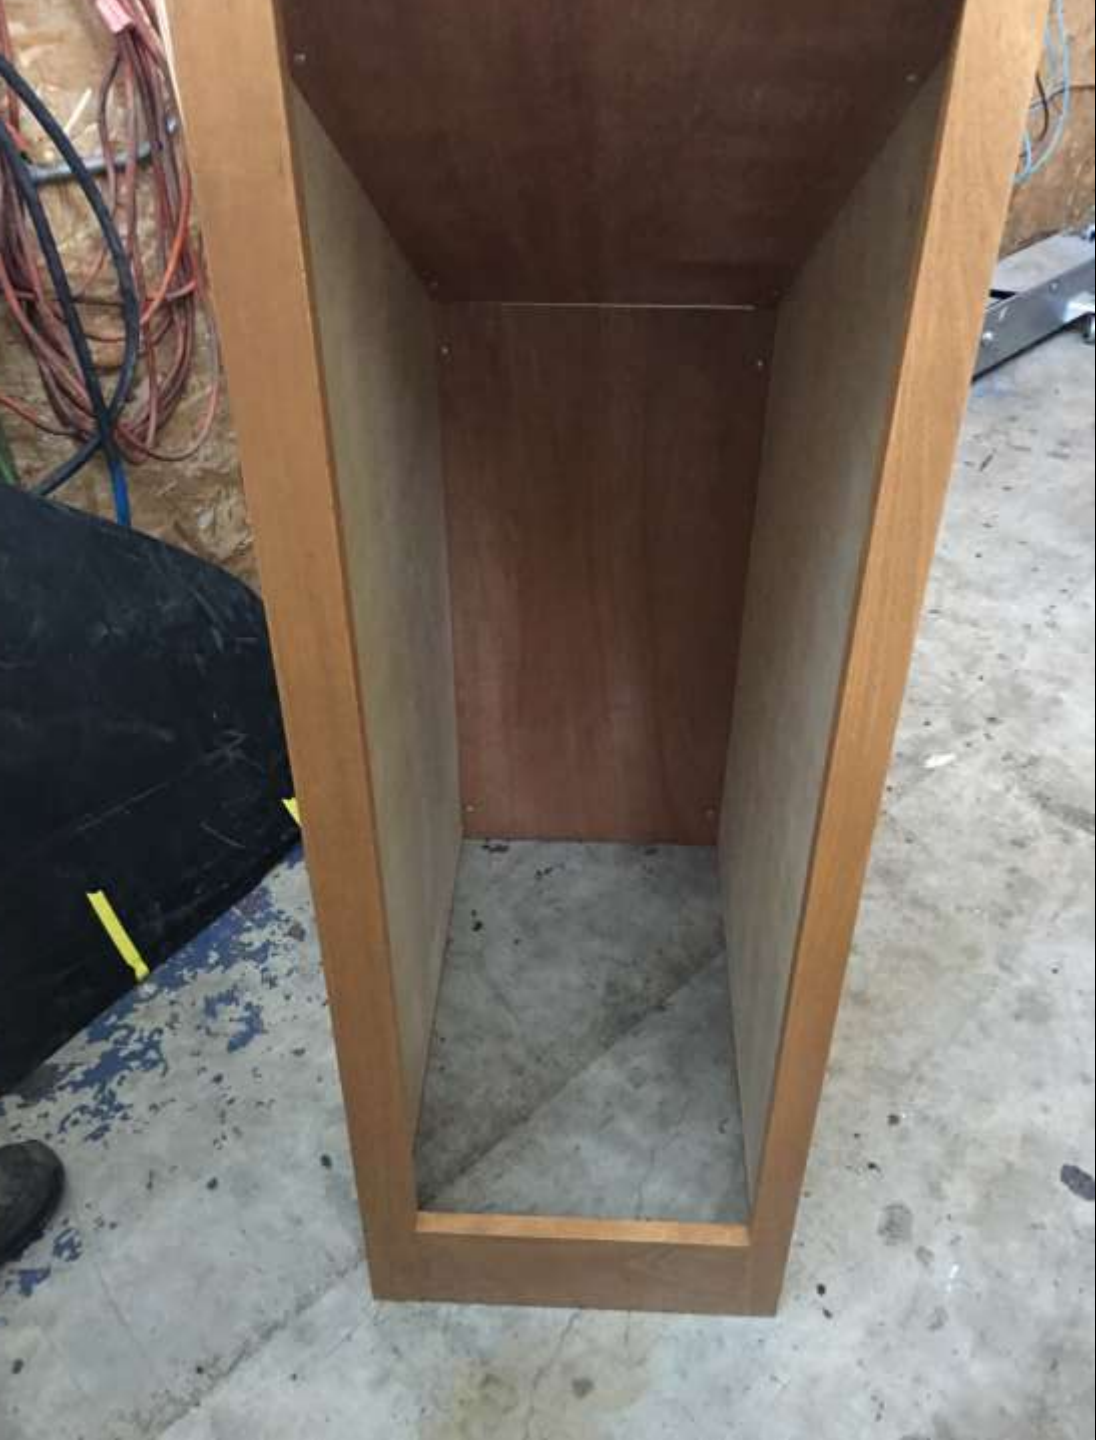
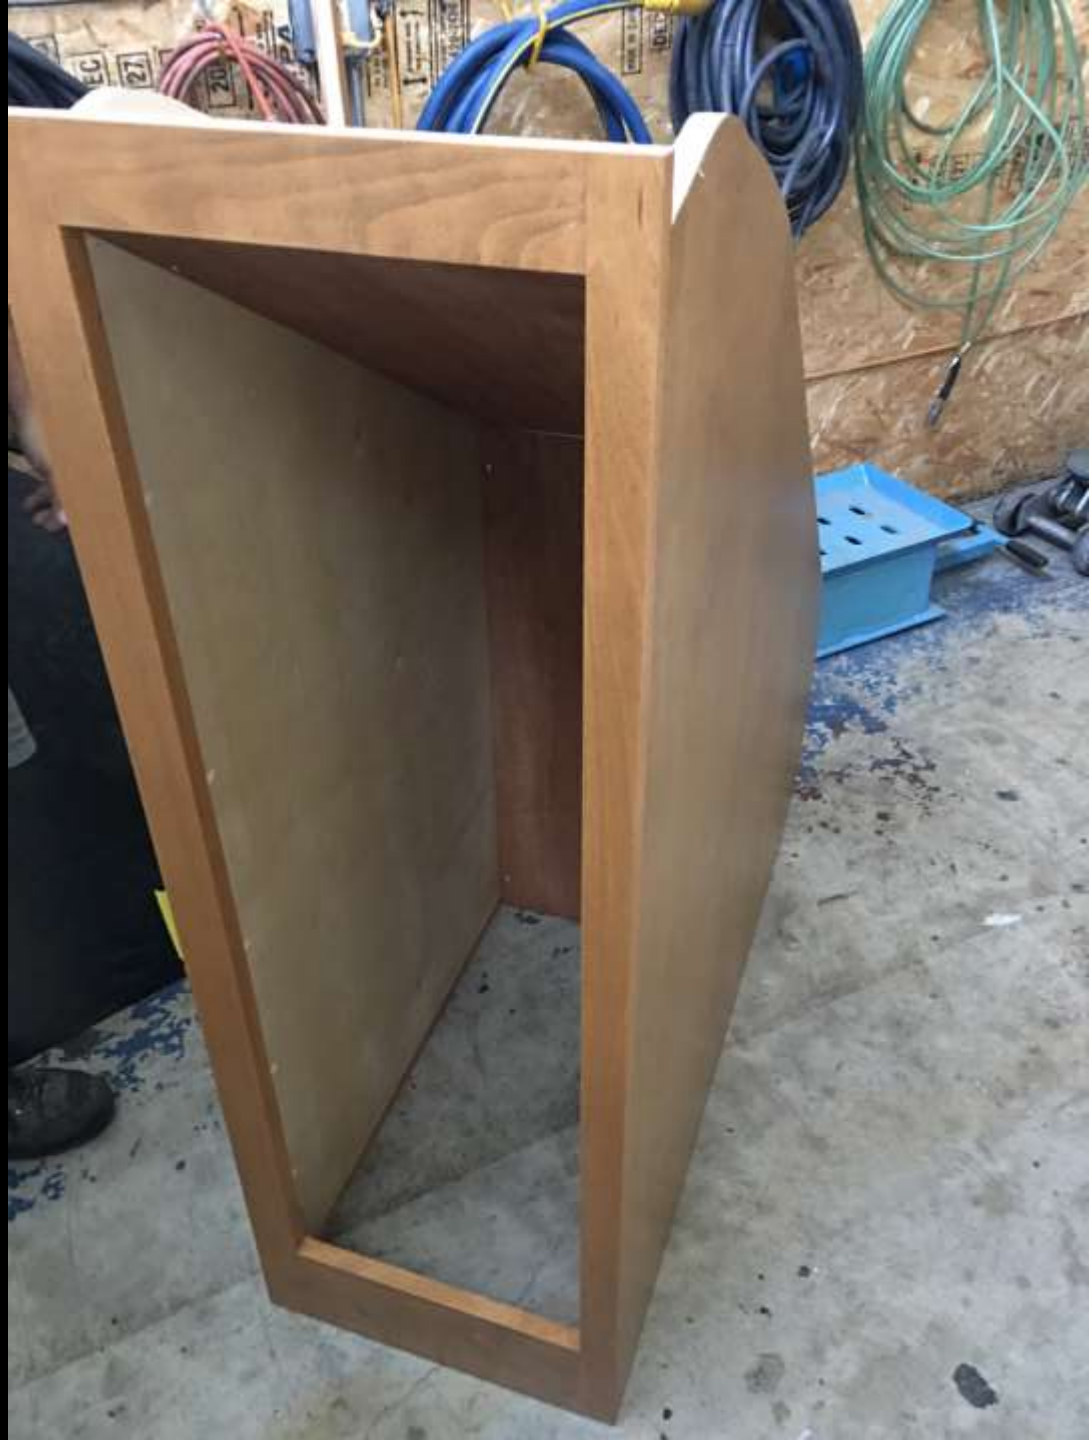
We removed all cabinets and interior paneling. NOW— however, you get an idea how there is no structure supporting the huge cap on our Ti's... So, we made 5/8" plywood veneer boxes, for hanging clothing, and anchored them to the frame of the trailer behind the cap. Then framed between them. This provided all the structure to support the cap better than factory.

There was about 18" of space in front of the cap at the most, 11" at the least. Where the mattress was to sit, moved forward about 12" from the original spot it sat. 6" from the drawers and another 6" to gain a full length queen mattress instead of the short one it came with.

New bed platform  
screwed down,  $\frac{3}{4}$ " ply  
cantilevers over original  
support in trailer frame.

Closed cell foam backed  
with space blanket  
material, provides  
superior reflective, and  
conductive, as well as  
convective insulation over  
stock.

Space blanket back  
assures cap could still be  
removed after closed cell  
foam is applied in the  
framing.

Wired for additional and  
updated charging and  
power in the room.

Robert, owner of Quality RV in Eugene, Oregon conceived of using the closets structure to replace the structure of the framing we removed. The idea of functional structure is what made it possible to reclaim so much more space in that room.

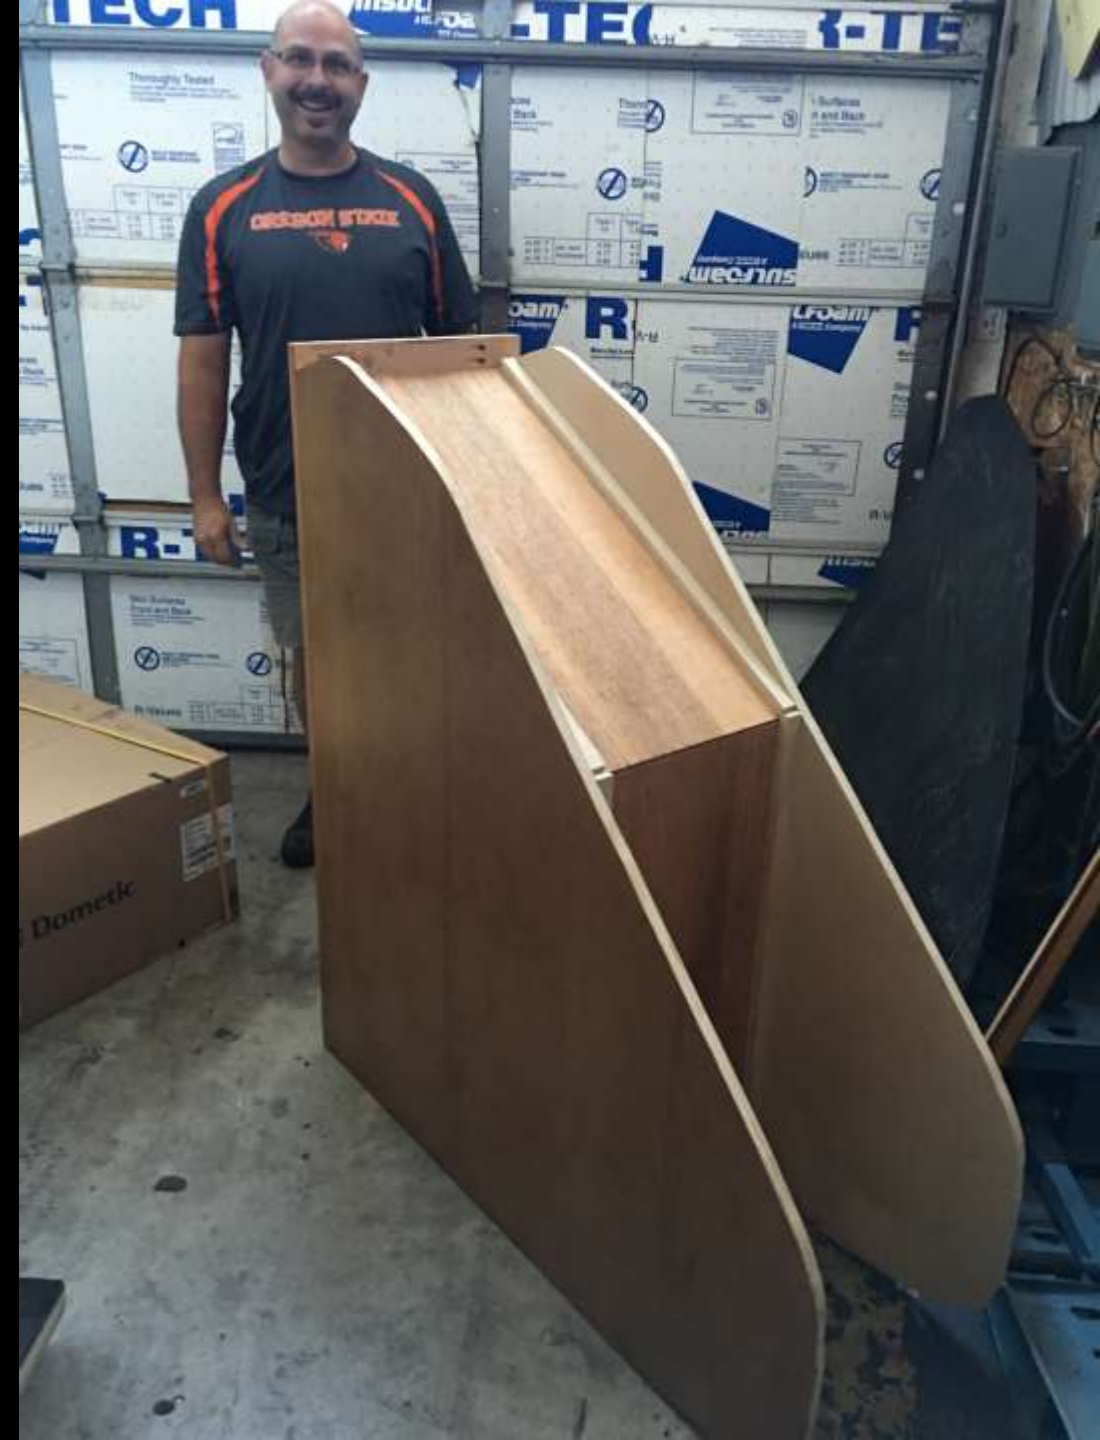
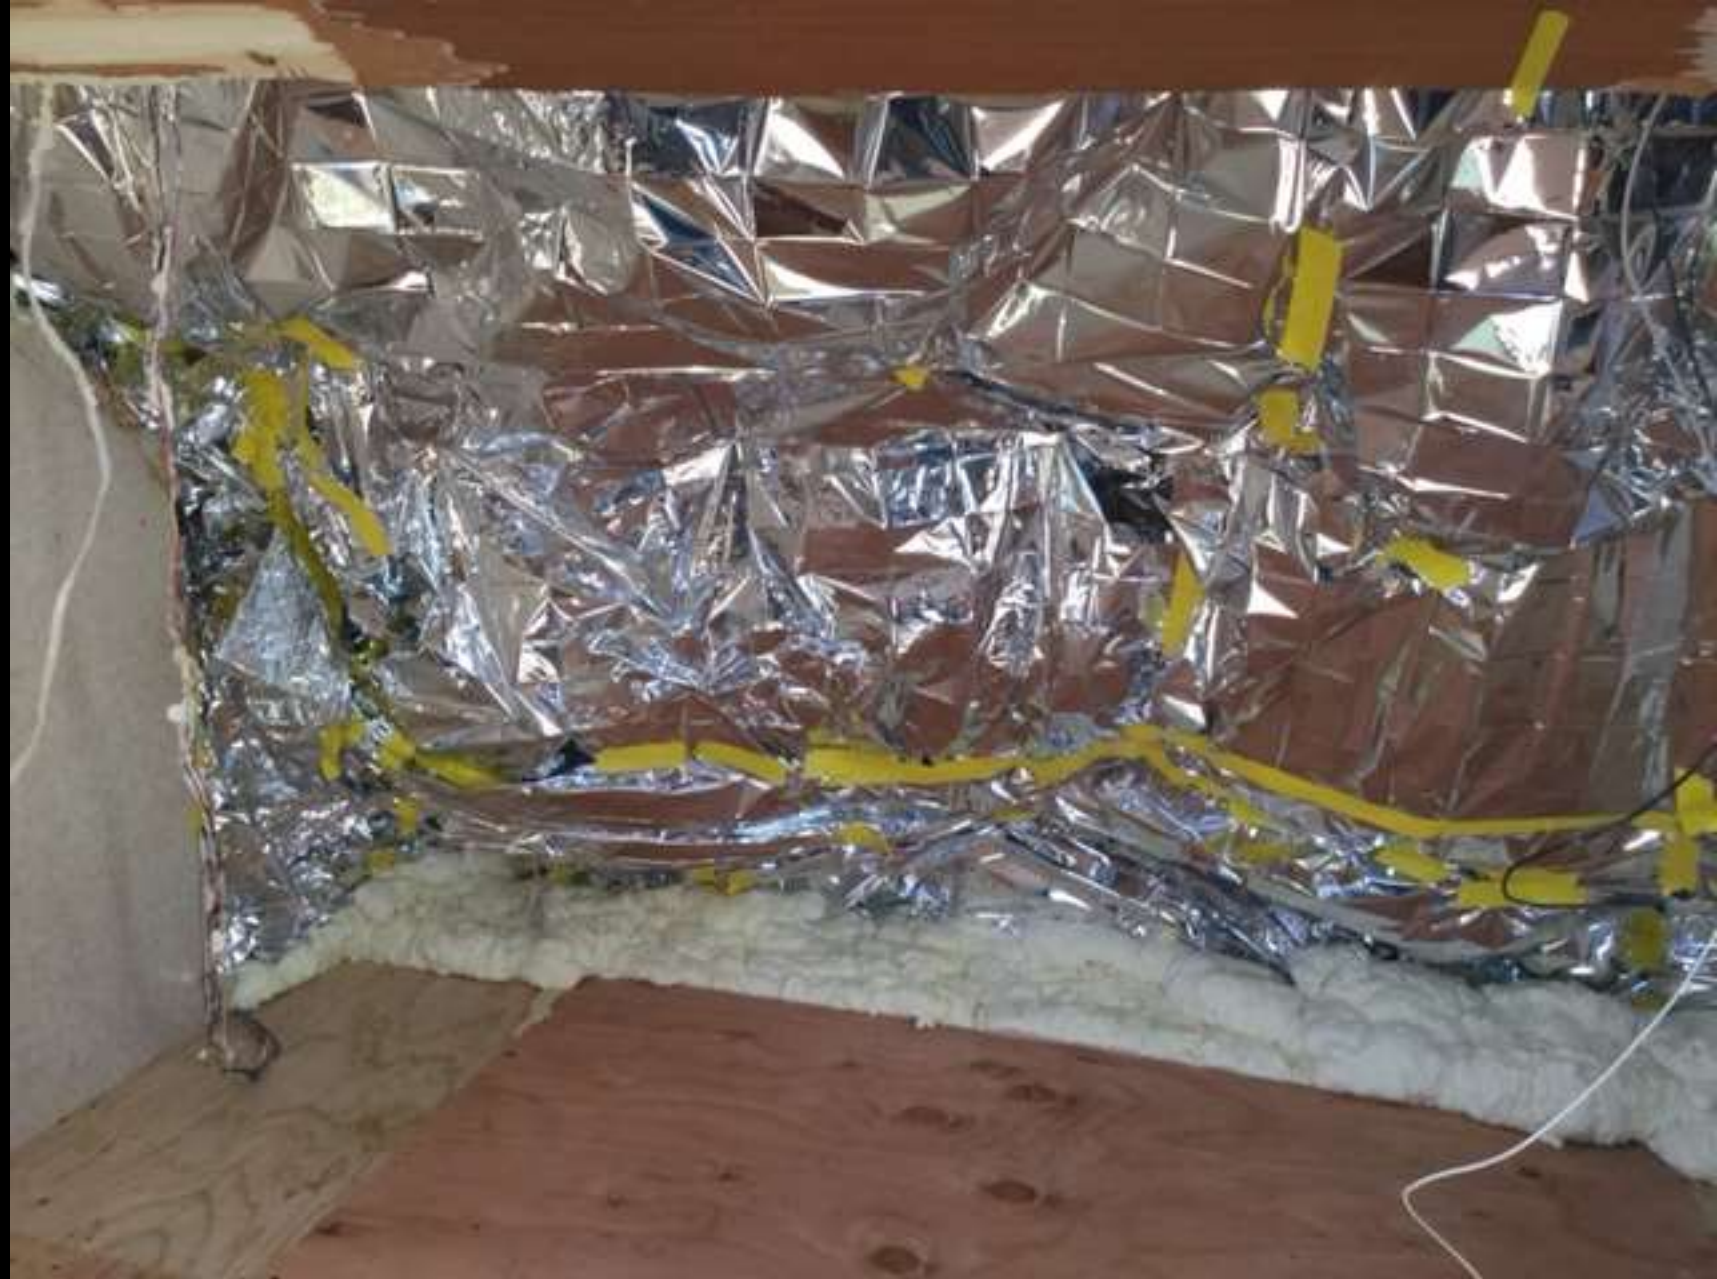
I know Robert and the boyz fought that space blanket concept. I think they may have redone this a few times before they felt confident they'd done what they wanted to do and accomplished what they wanted to accomplish.

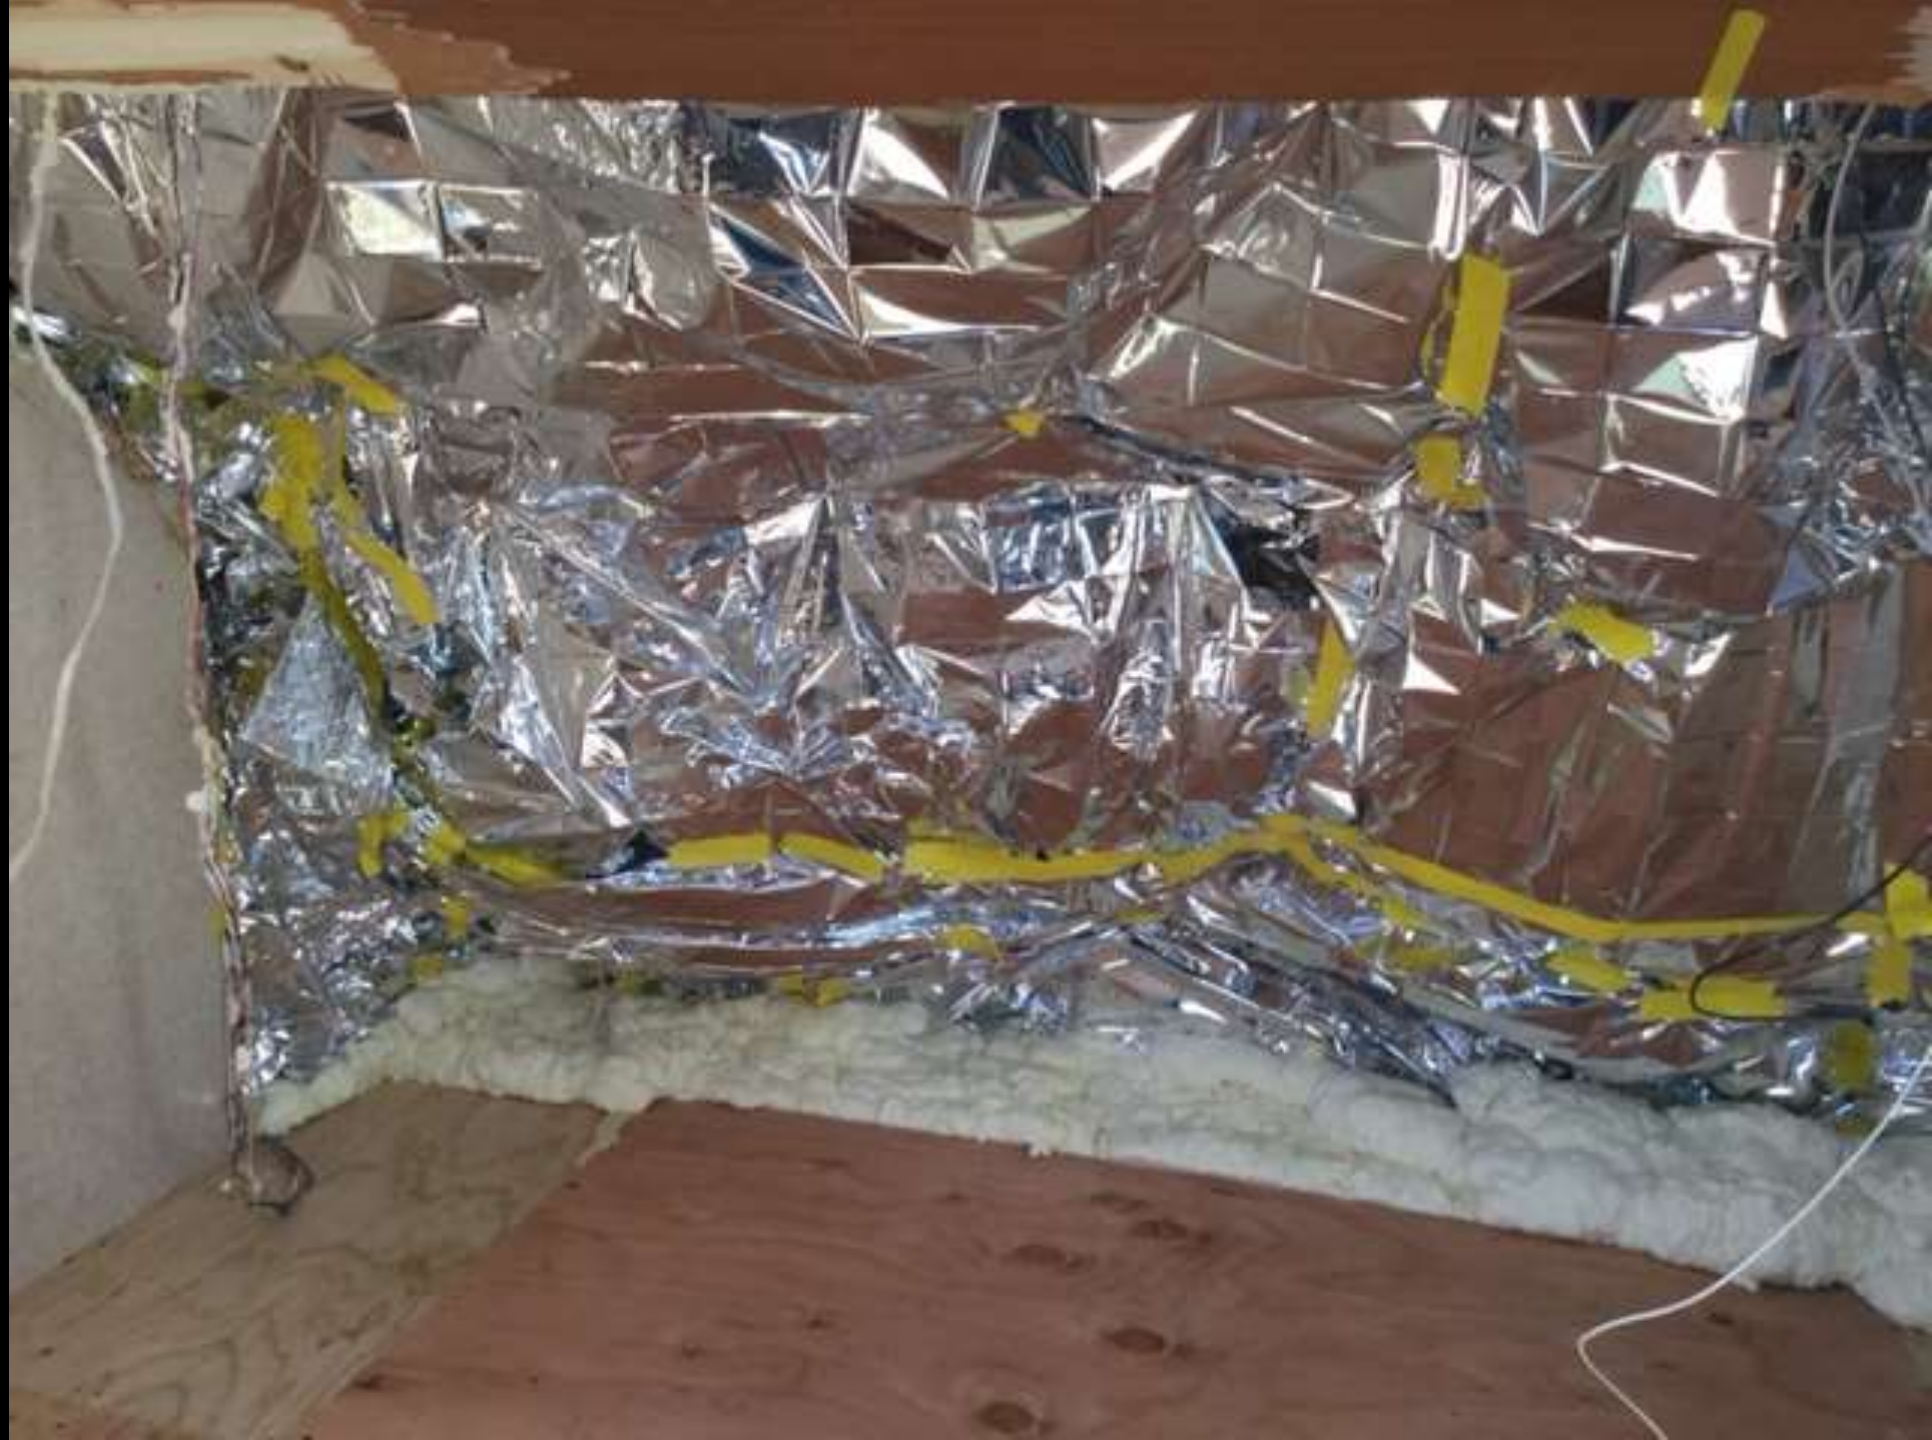
Closets installed to framing of the trailer walls, and floor bed frame structure.

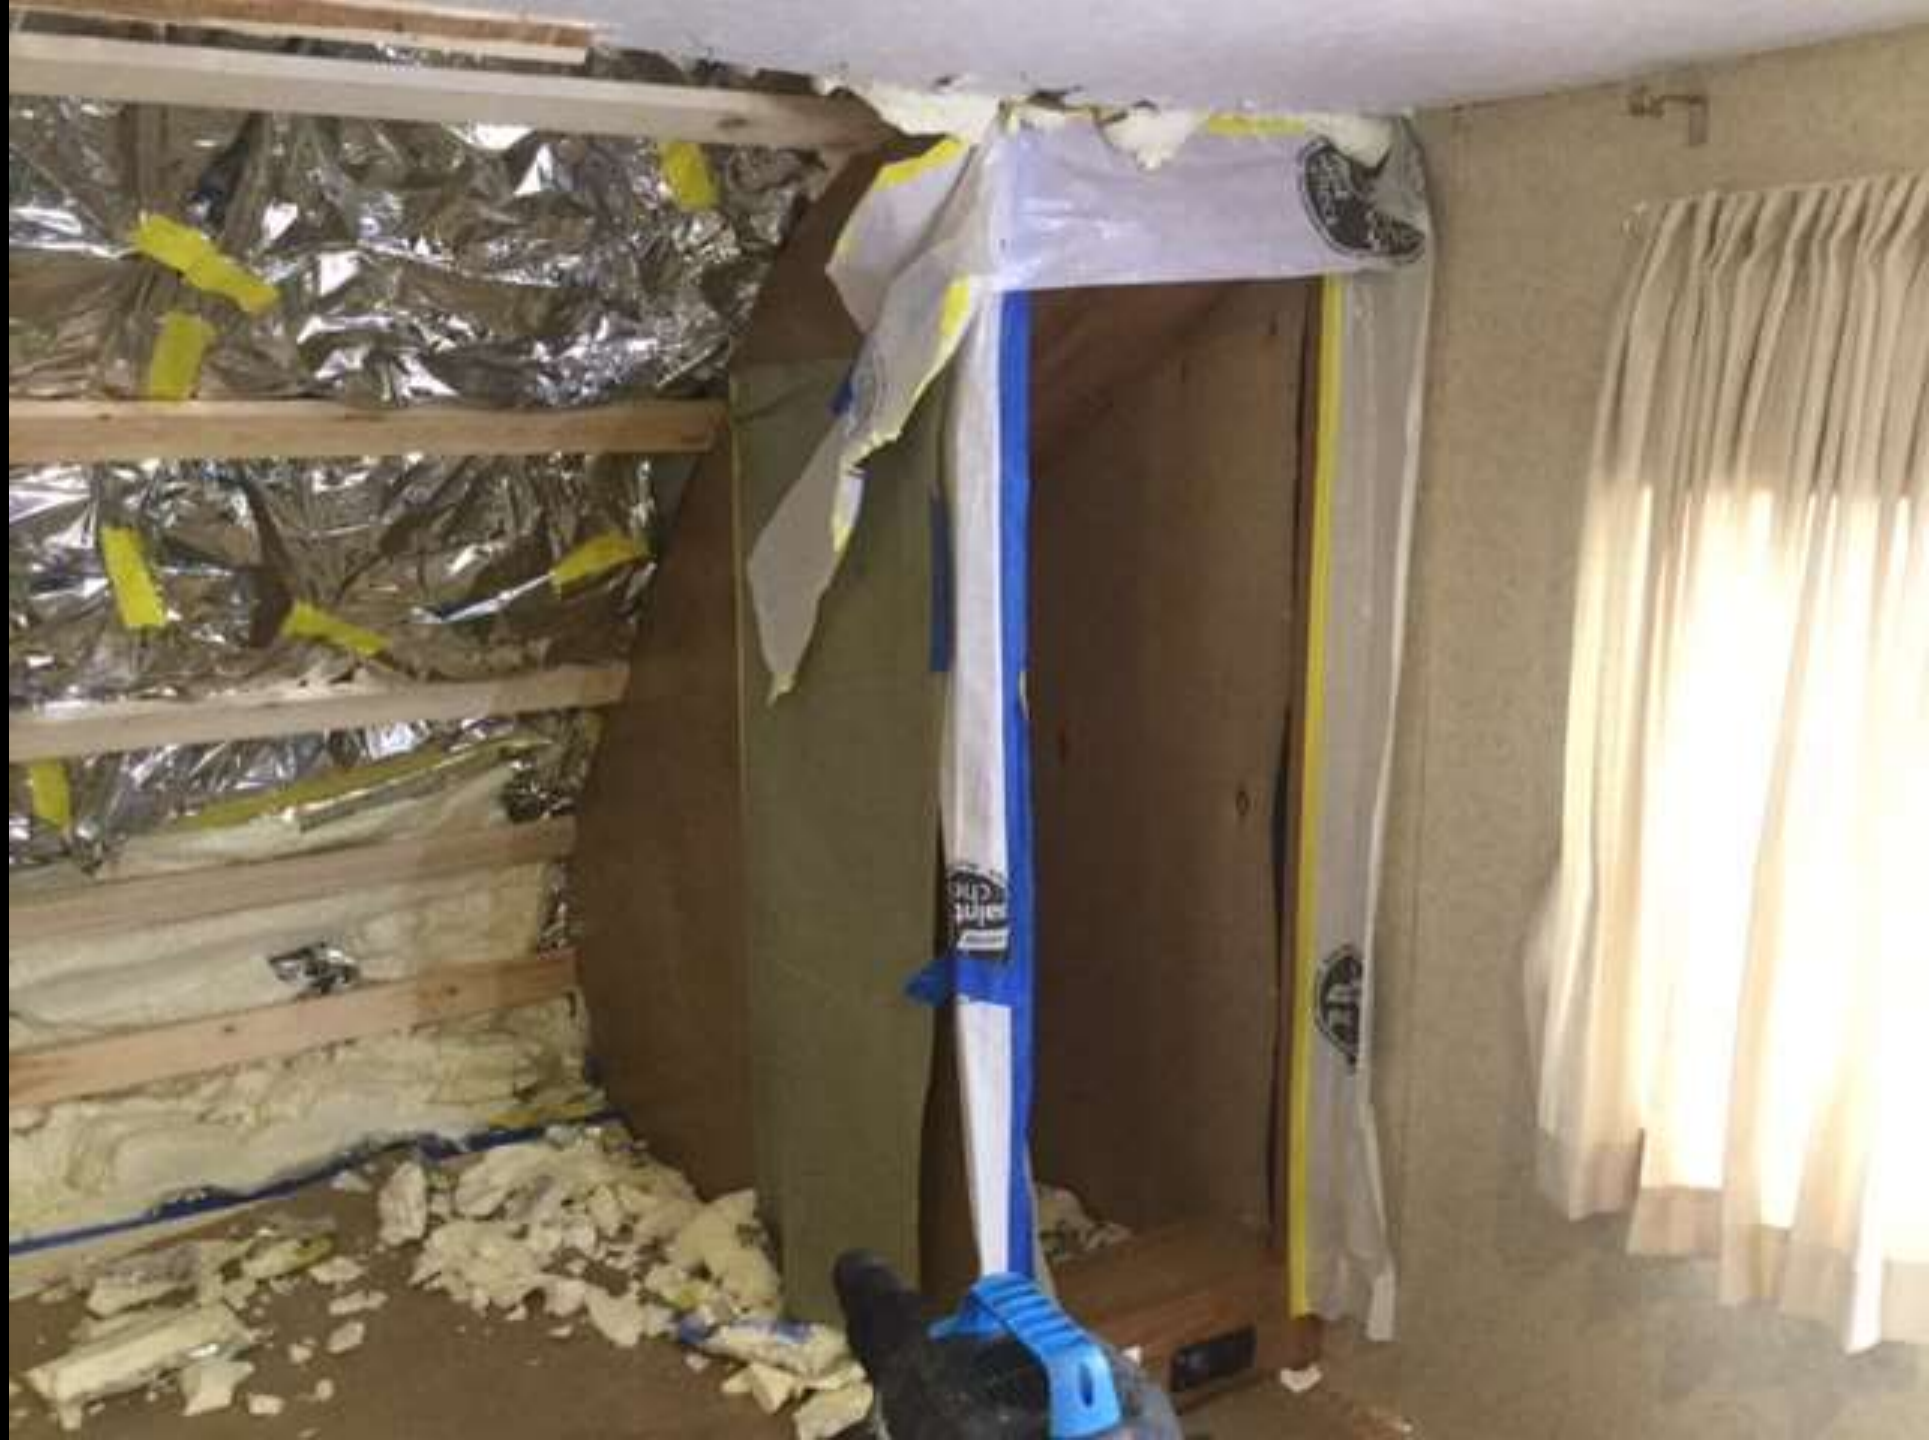
Closets reinforced to each other, screwed and glued to the trailer walls and frame. It's stronger and better insulated than it was from the factory for sure.

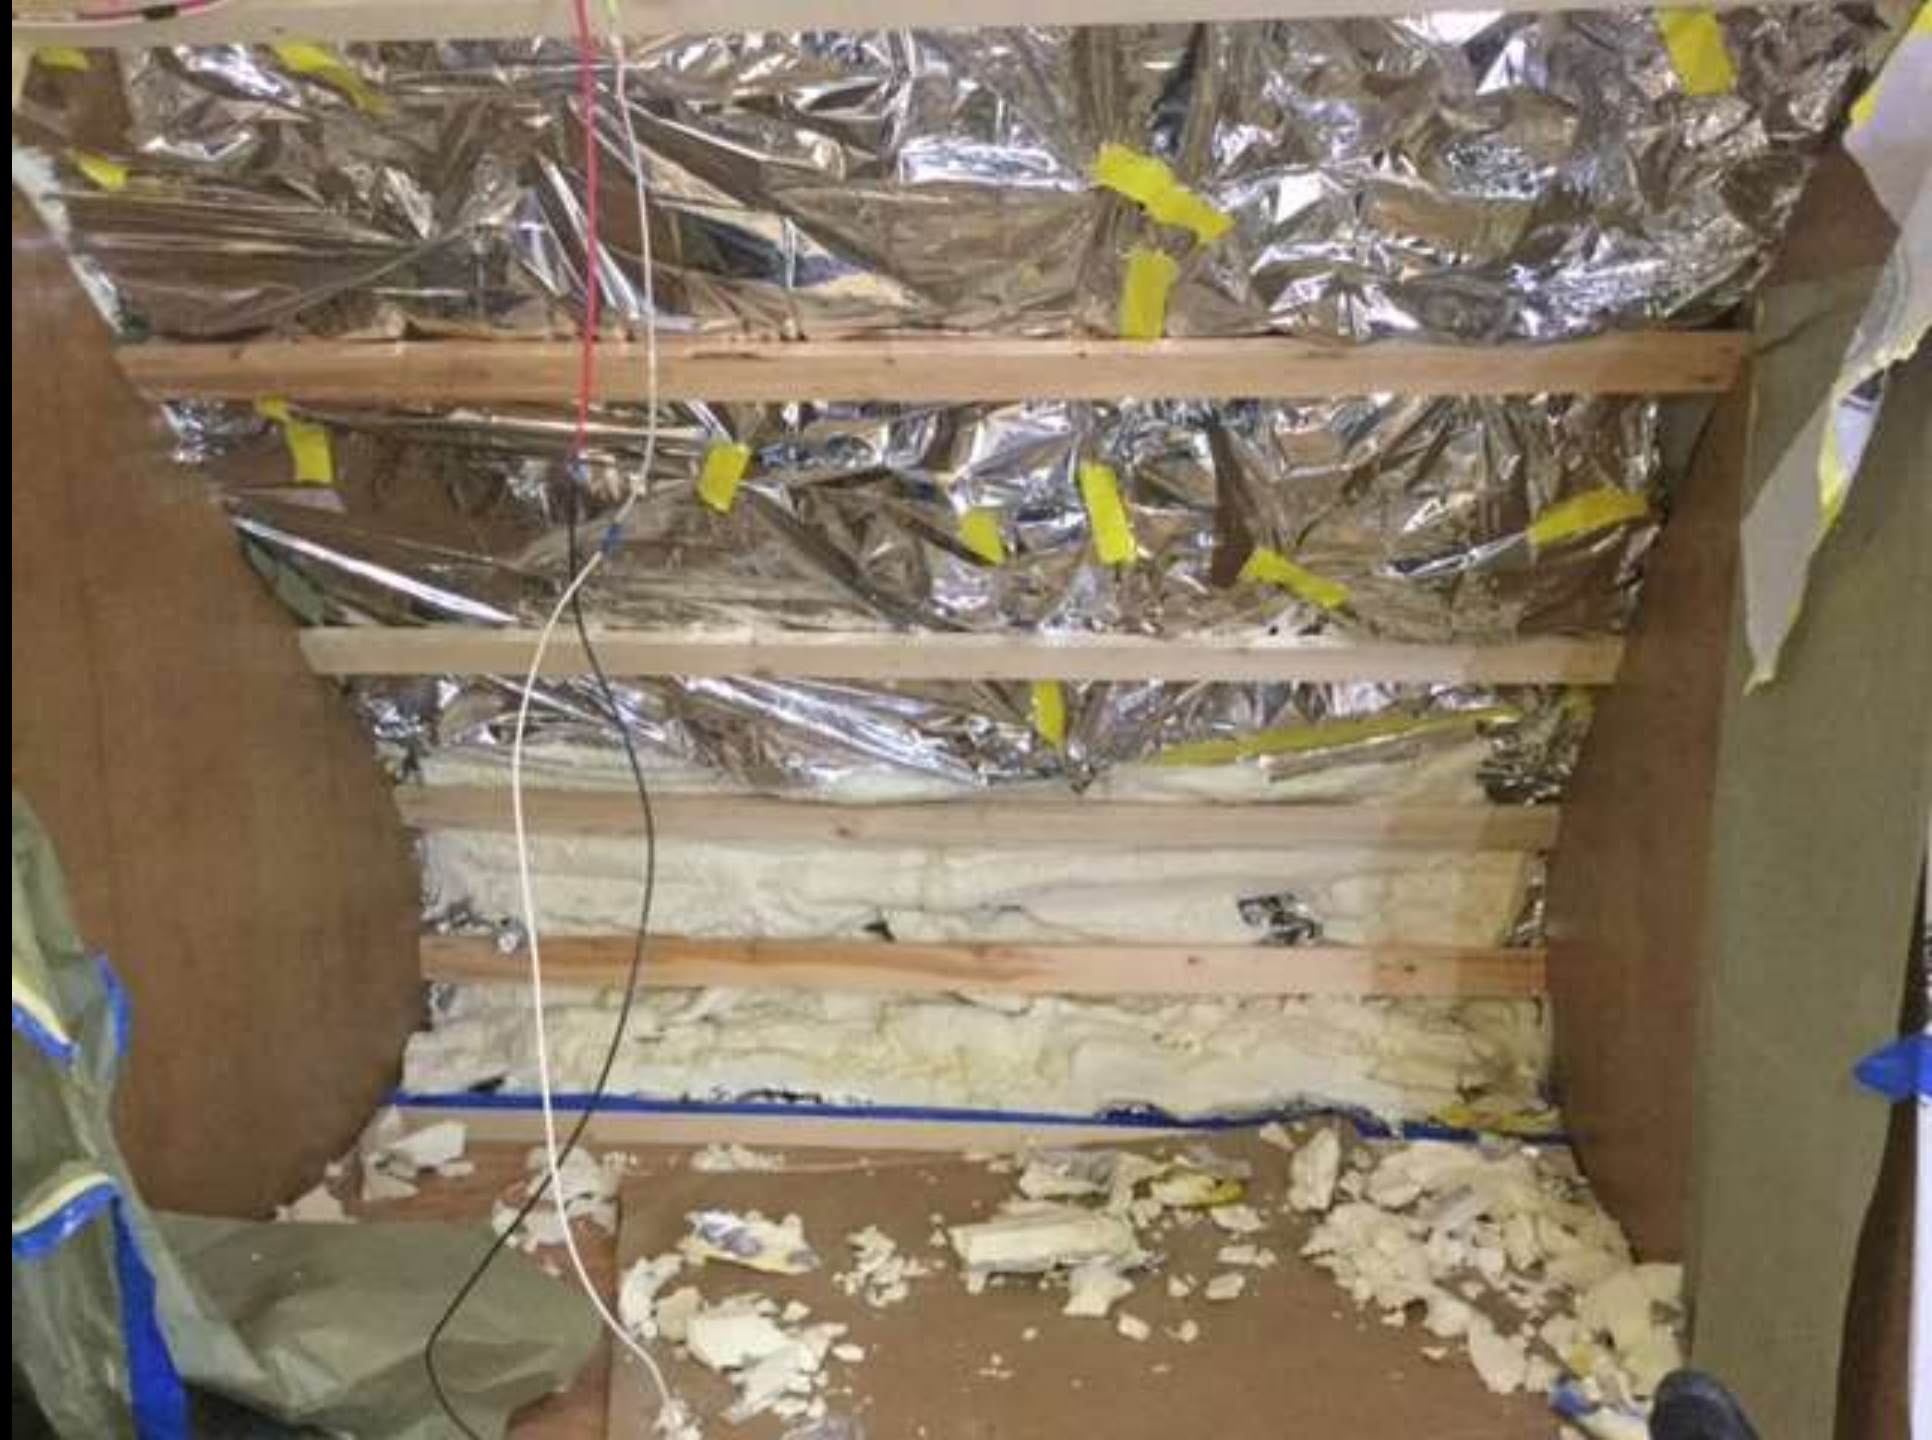
Foam insulation finally covered up that space blanket that was driving the team crazy.

That foam made a sound structural frame.

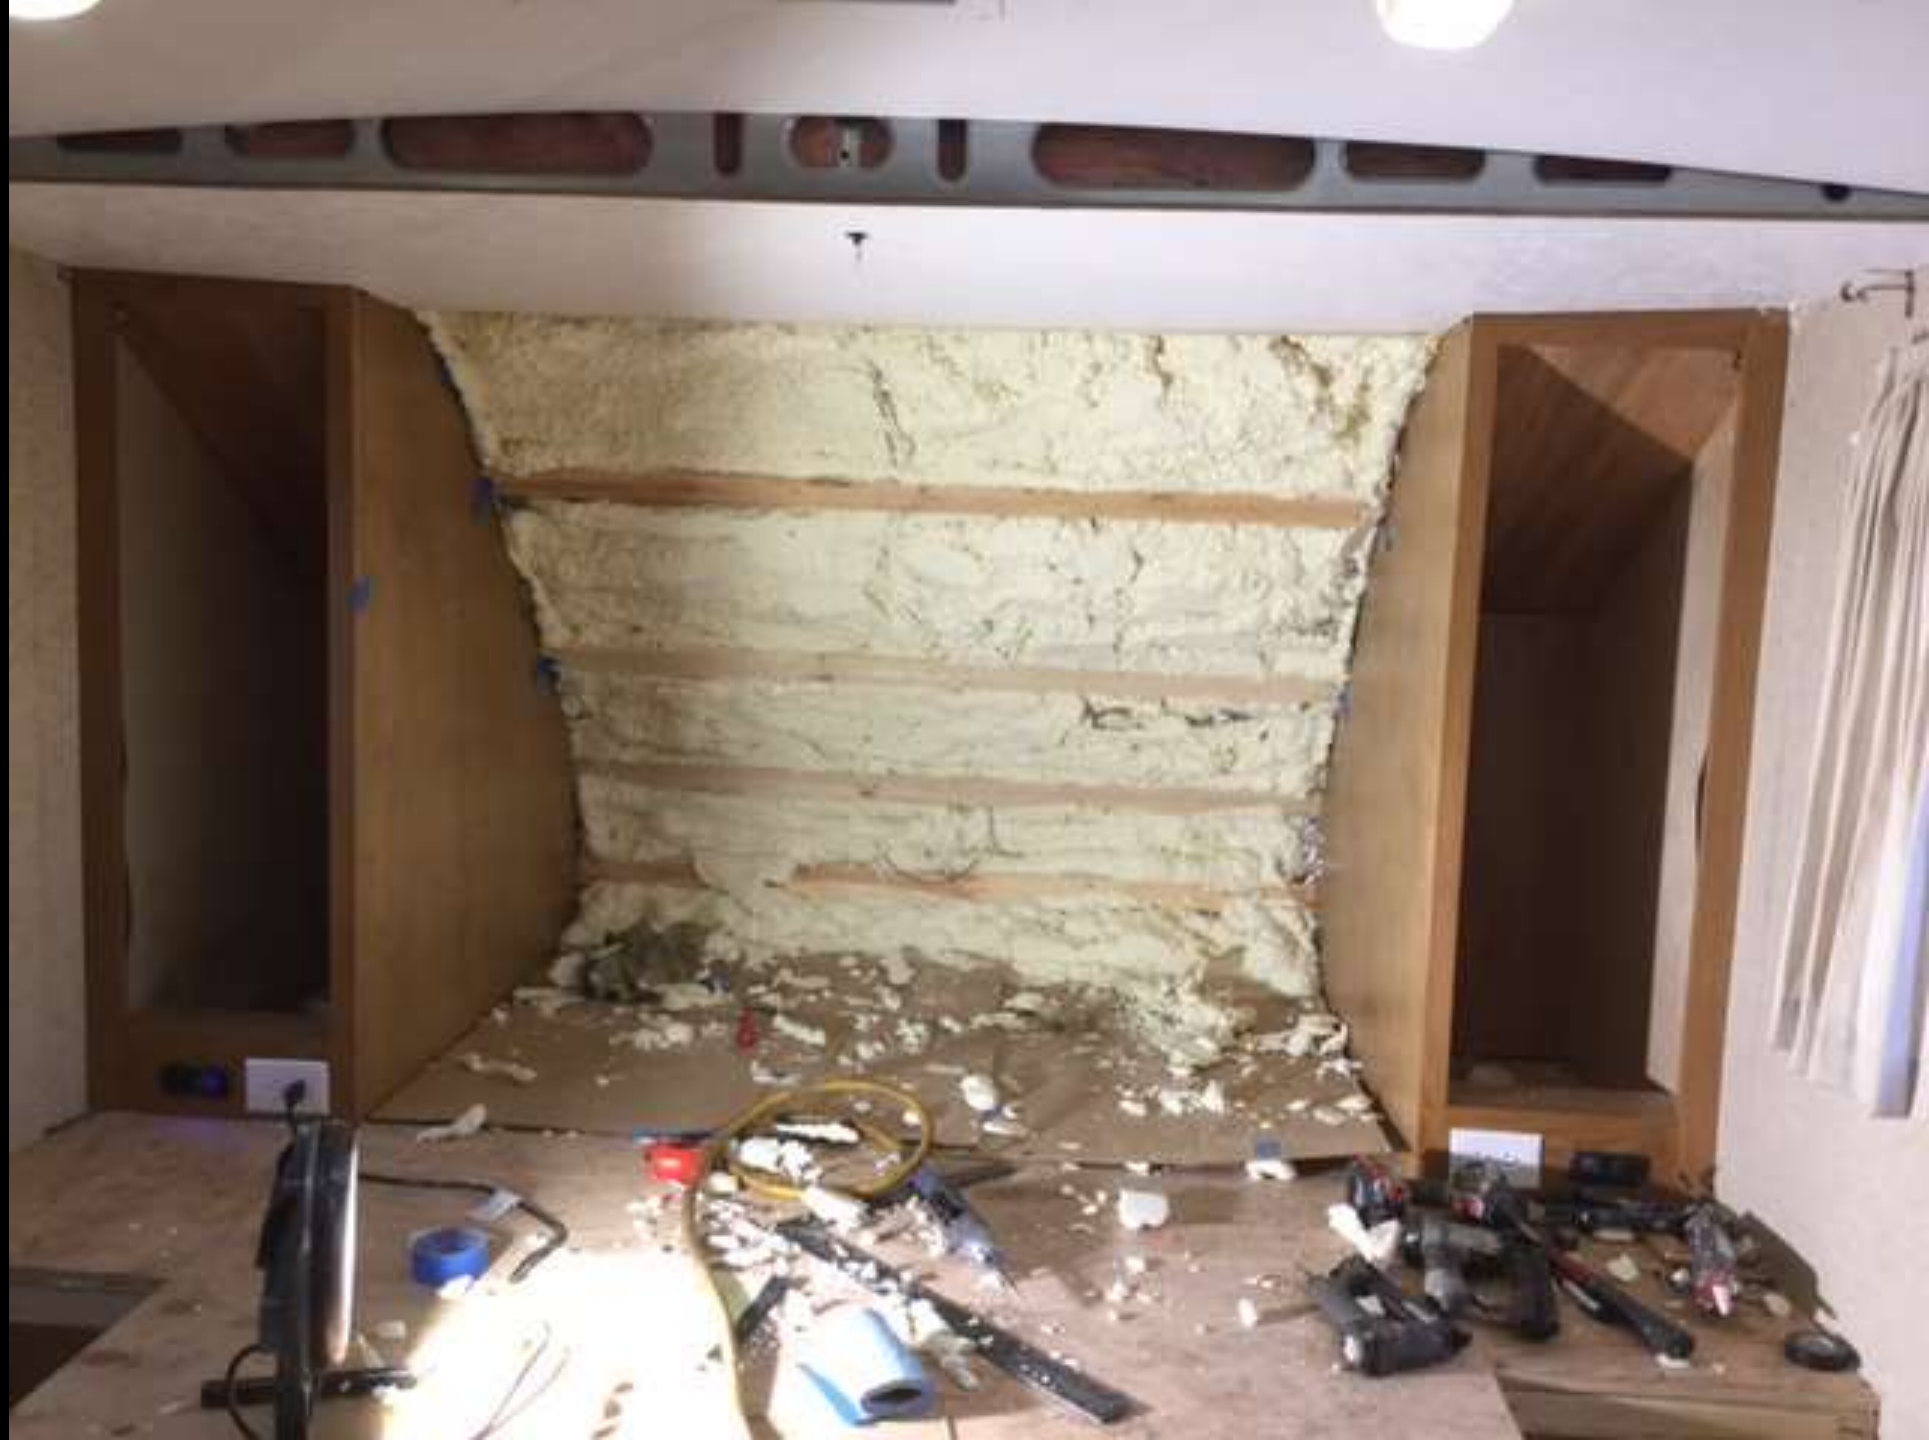
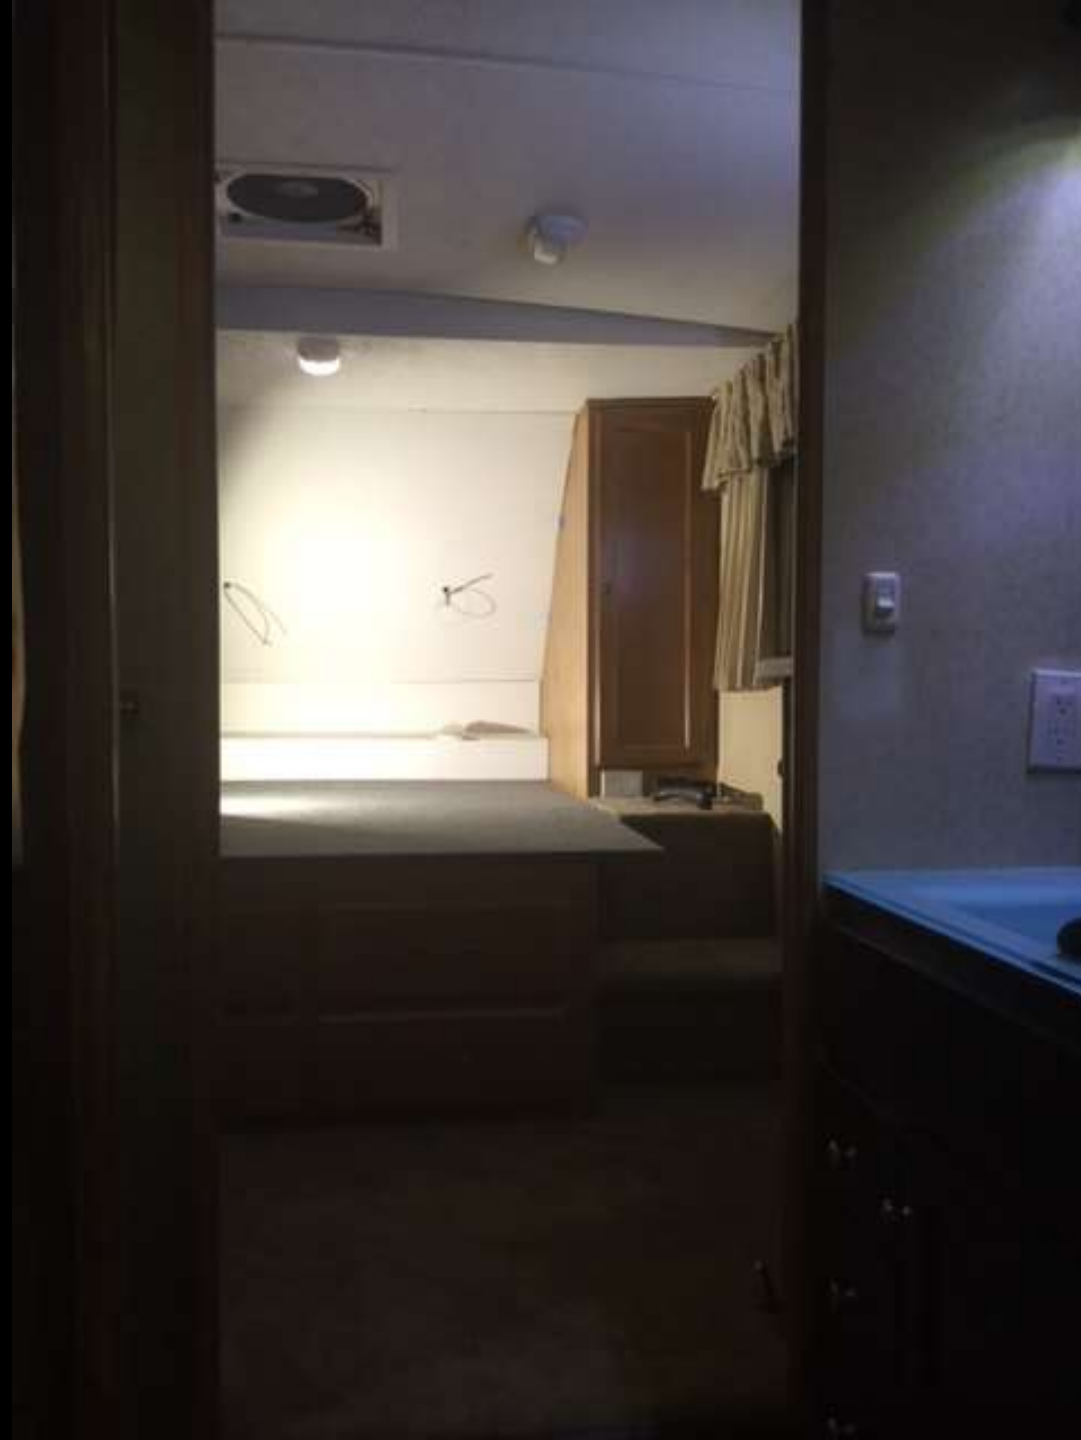
You can see my glass vanity on the right, with nice "Delta" spout, it's just like the nice stuff at home! Another great modification pictures of it further down the pdf.

In the center— see how FAR AWAY the front wall of the bed room is! That's a "pillow trough" in front of the full size mattress, so your heads not crammed up against the wall. It's nicer then most nice hotels I stay at.

Picture taken  
when finished,  
before mattress  
and lights.
