# '08 Titanium 25E30 Bedroom Remodel

by Tony Ellsworth

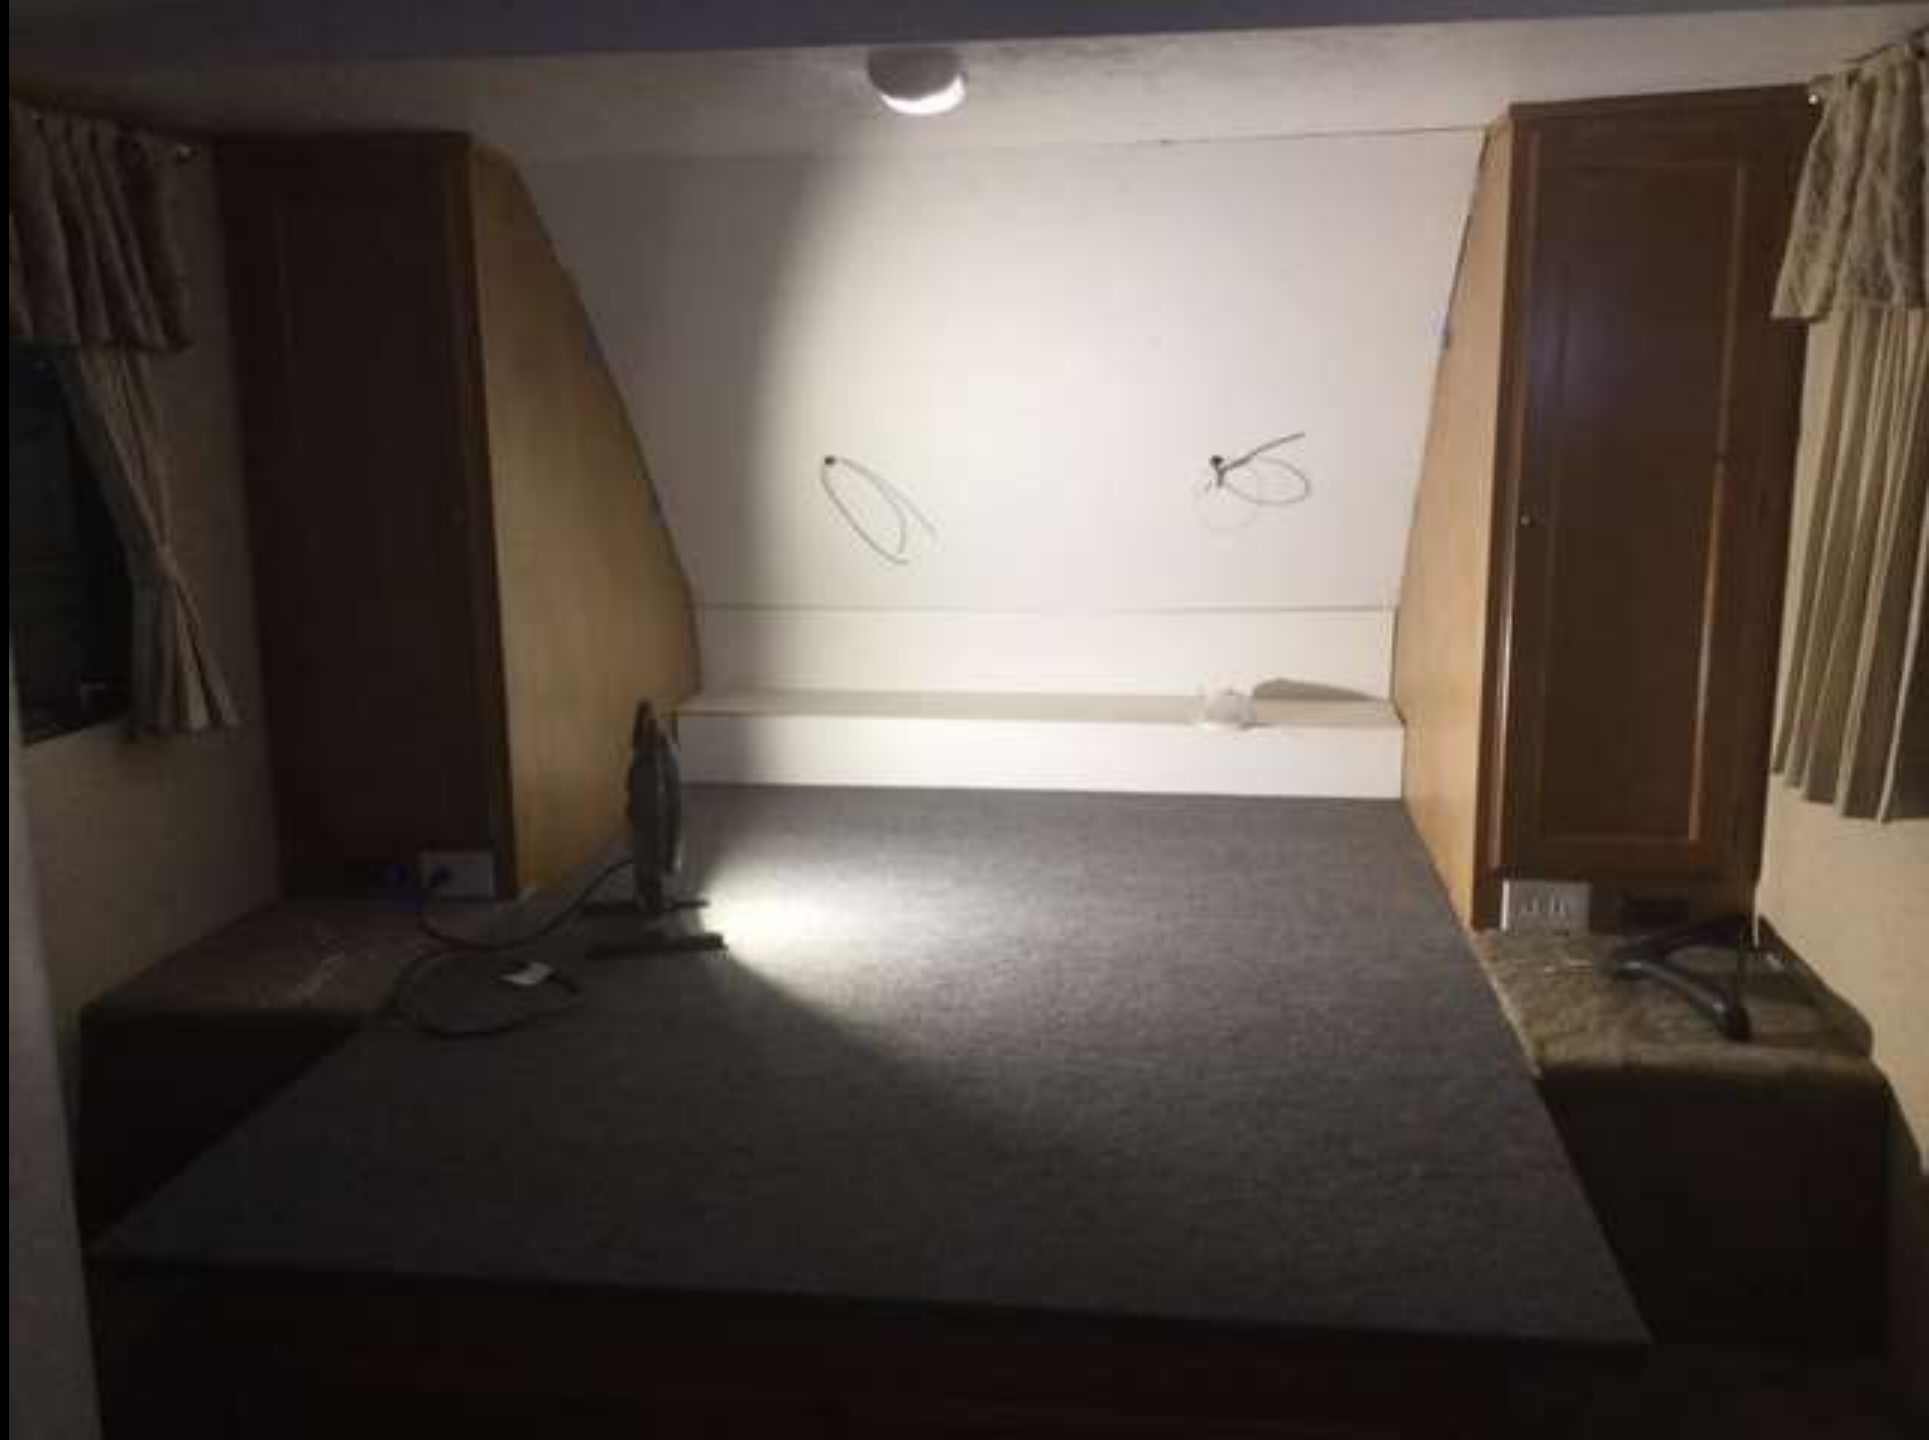
Picture taken  
when finished,  
before mattress  
and lights.

That's the amount of space to walk around the bed, dress in front of the wardrobe. I even had room in the corner where the TV was intended to go, to build in a nice make up area for Chiapin.

Seriously, tons of room in the room now, even with the full size mattress, and the 10" pillow trough in front of the mattress.

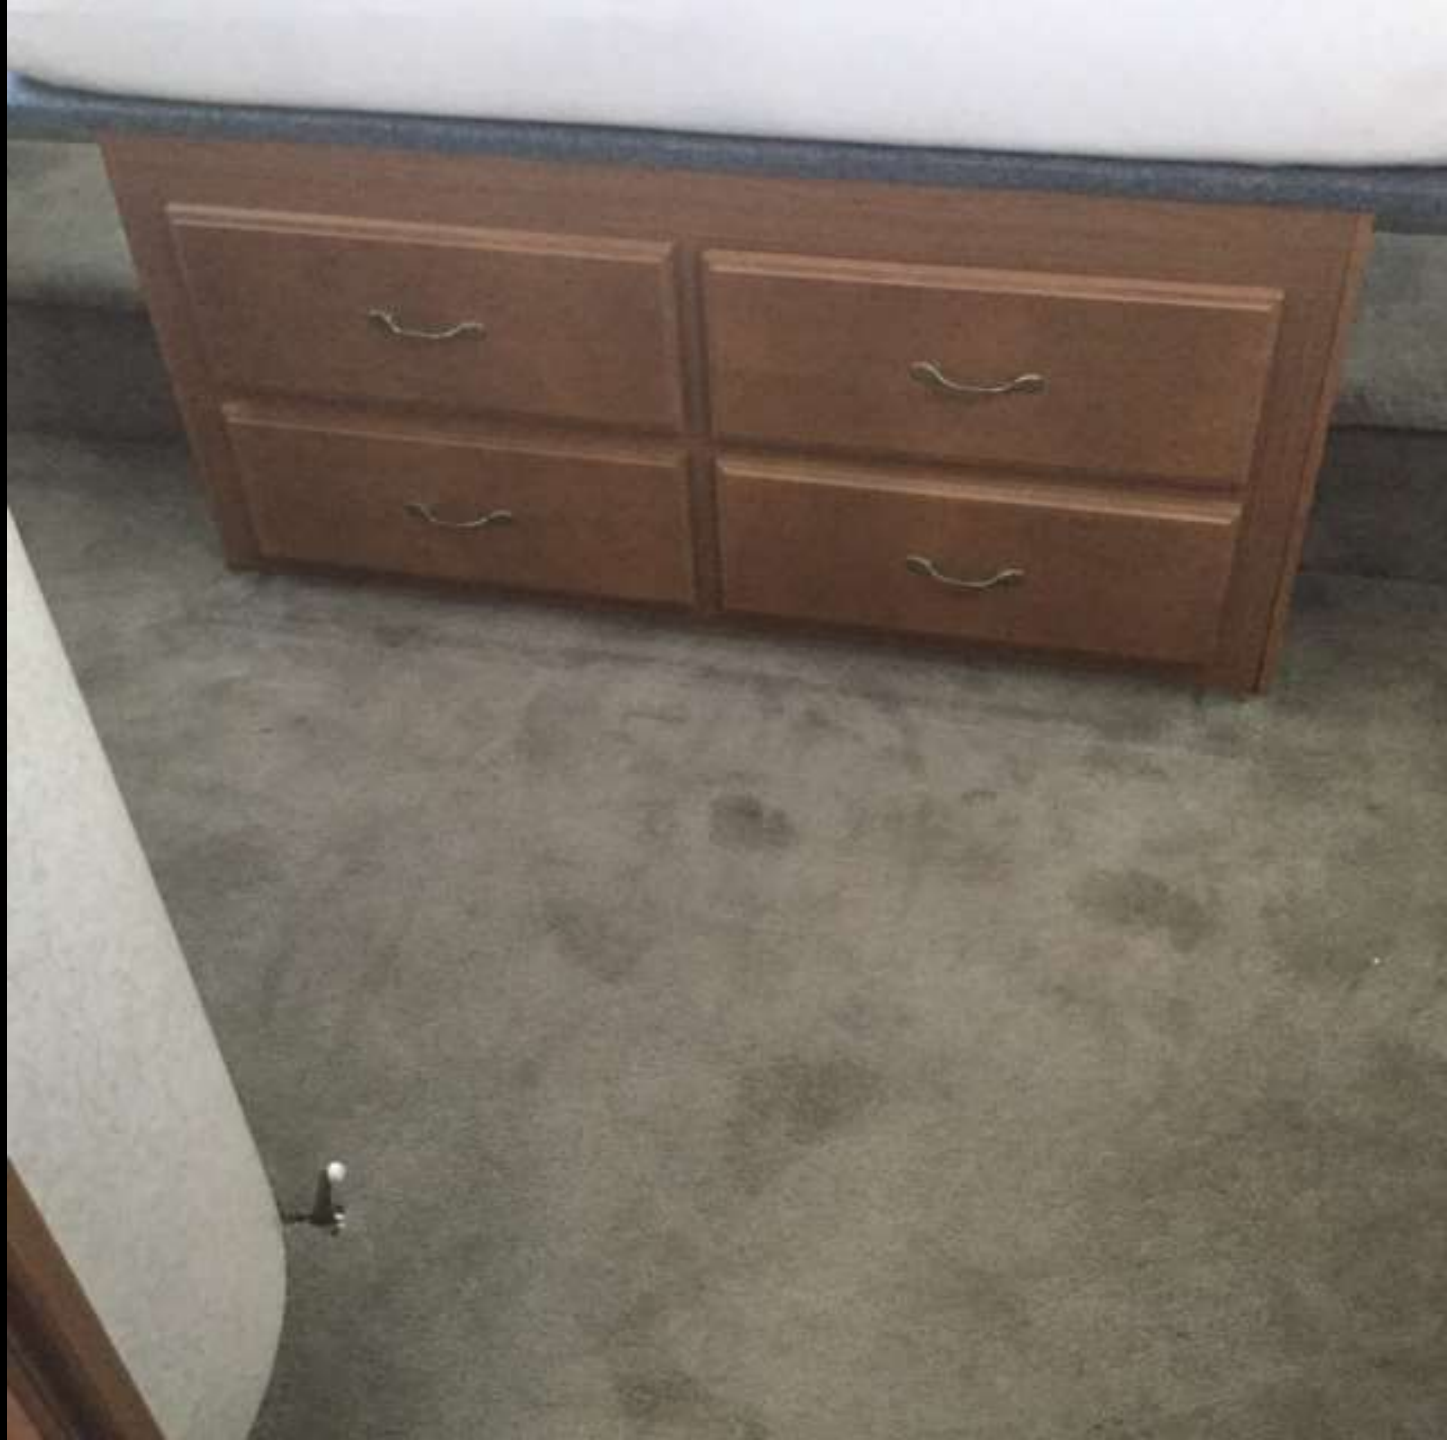
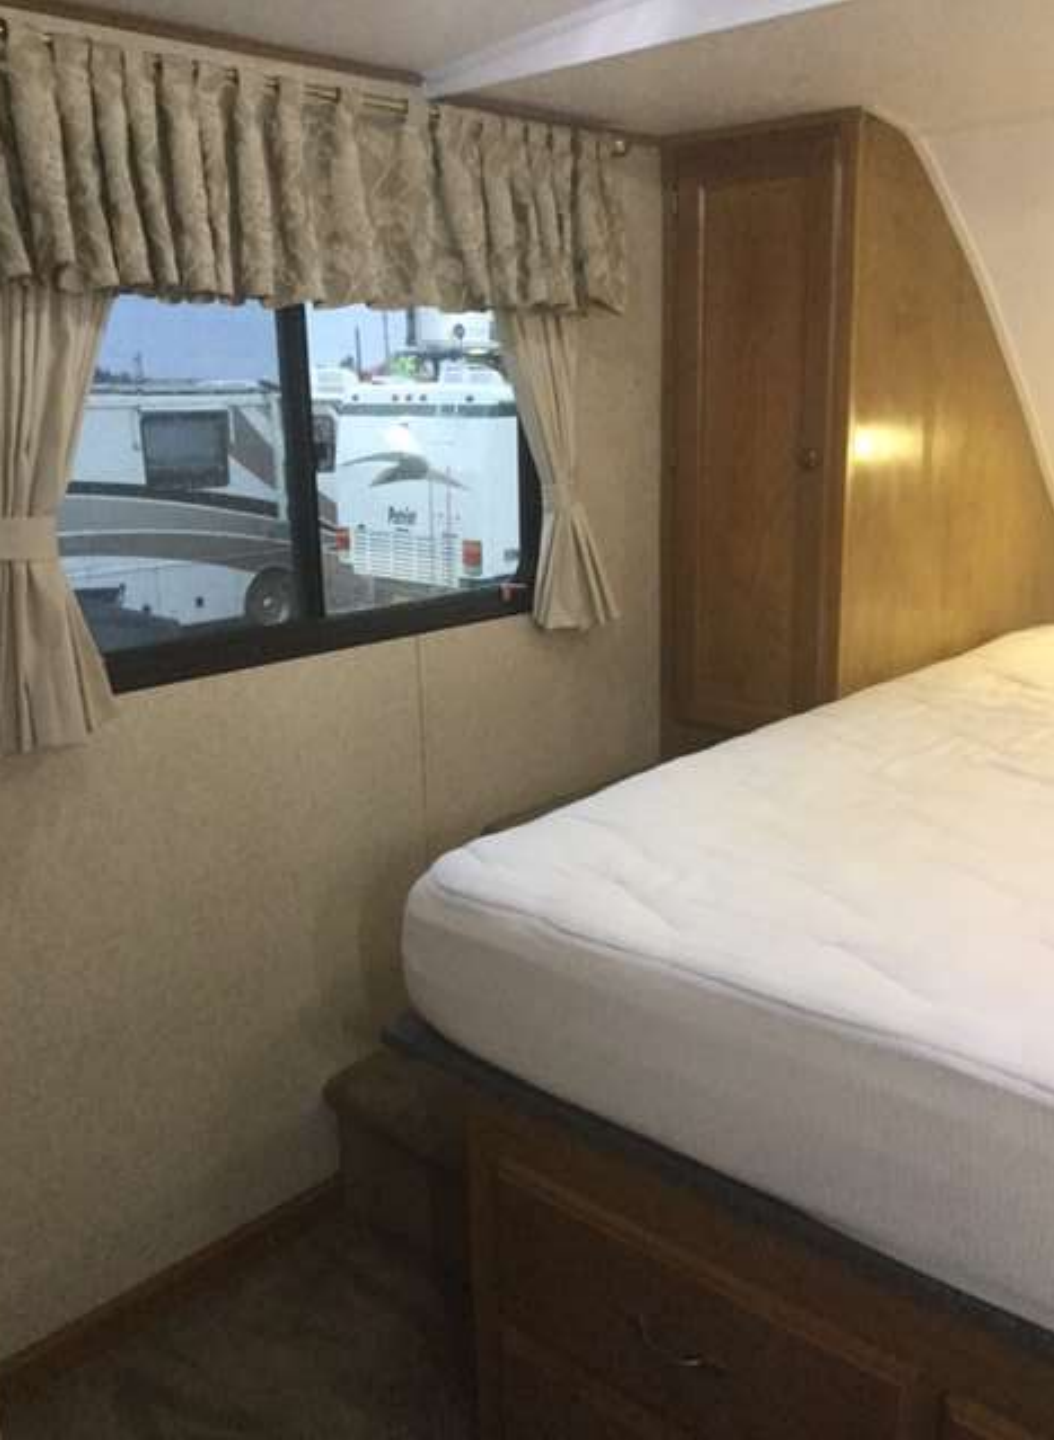
Closets on  
both sides,  
and space  
around the  
bed

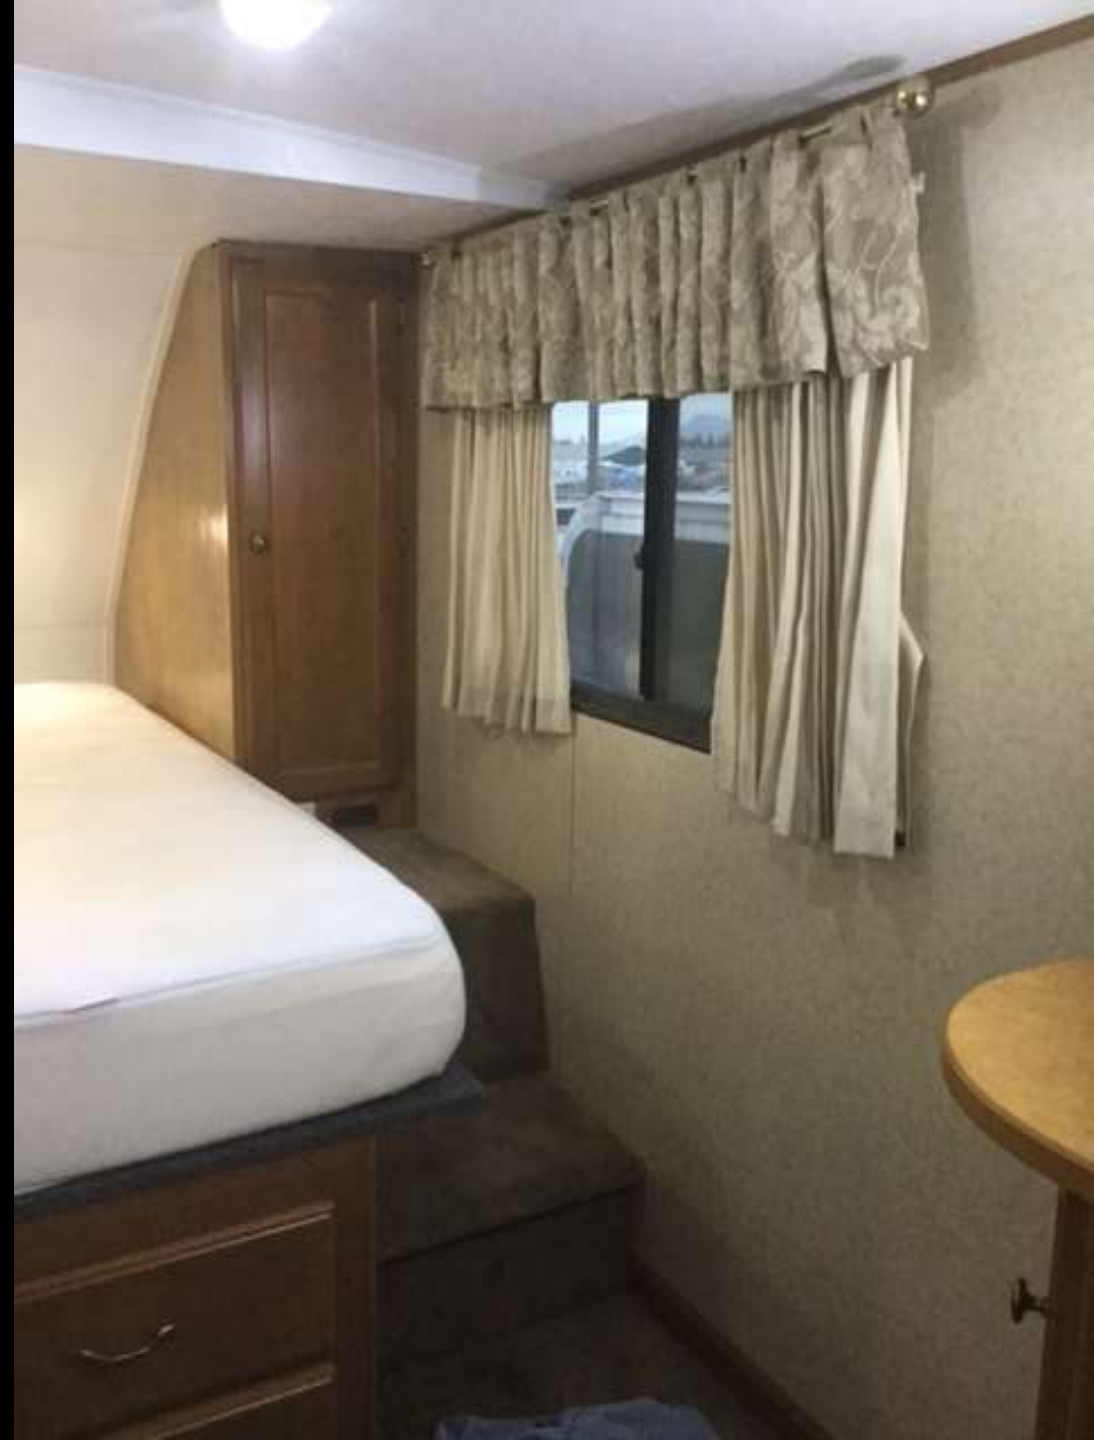
View from above the  
“Pillow Trough”  
About 12” in front of  
the mattress. So your  
head isn’t against the  
wall. The Bed feels  
bigger than any bed,  
with a head board.

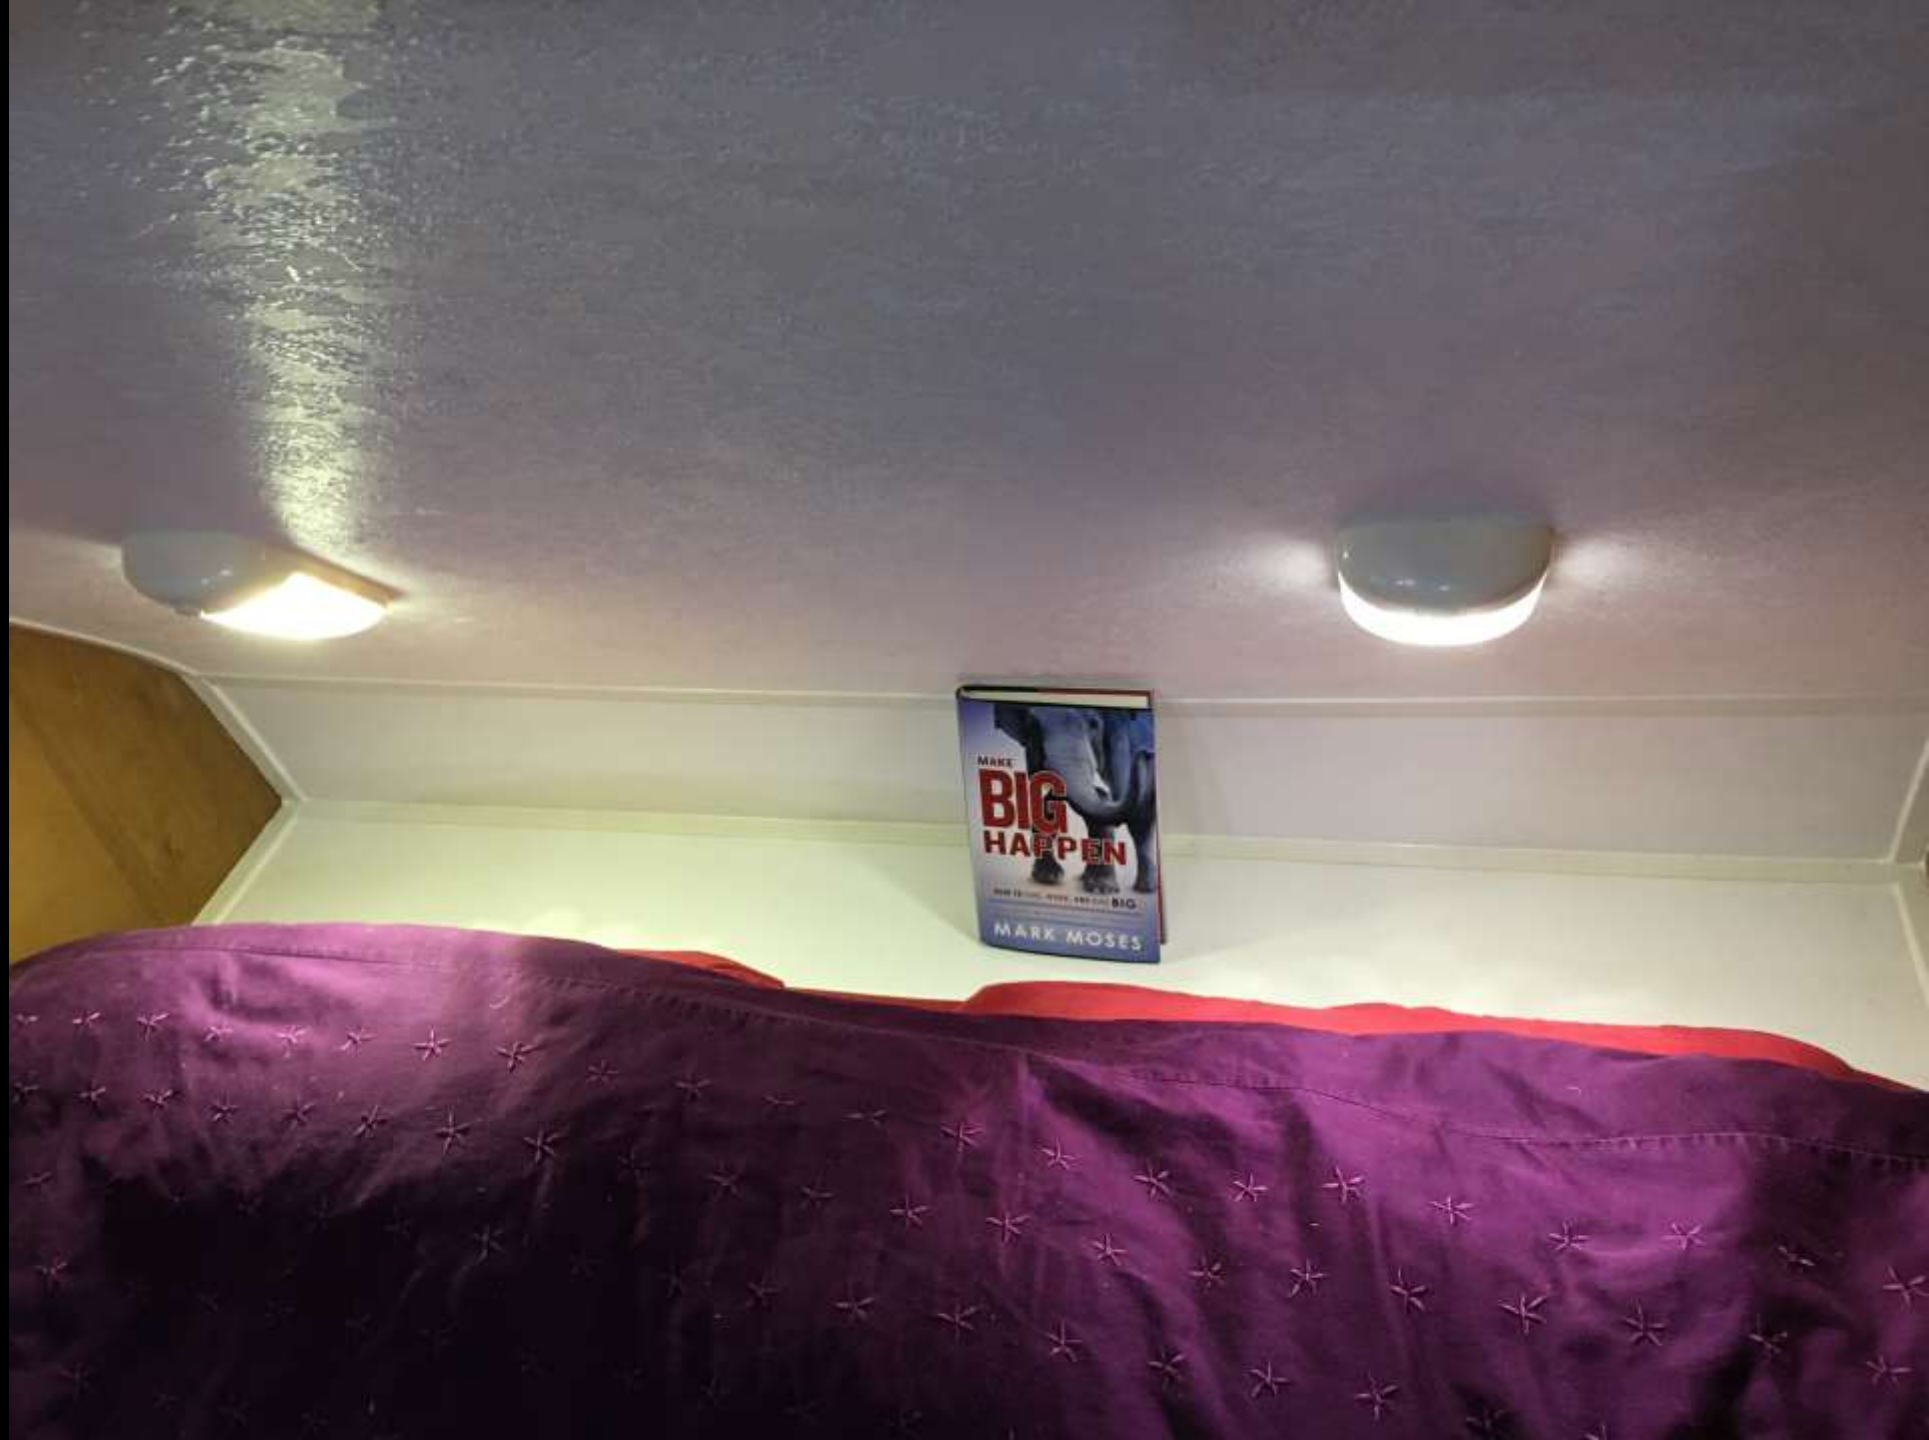
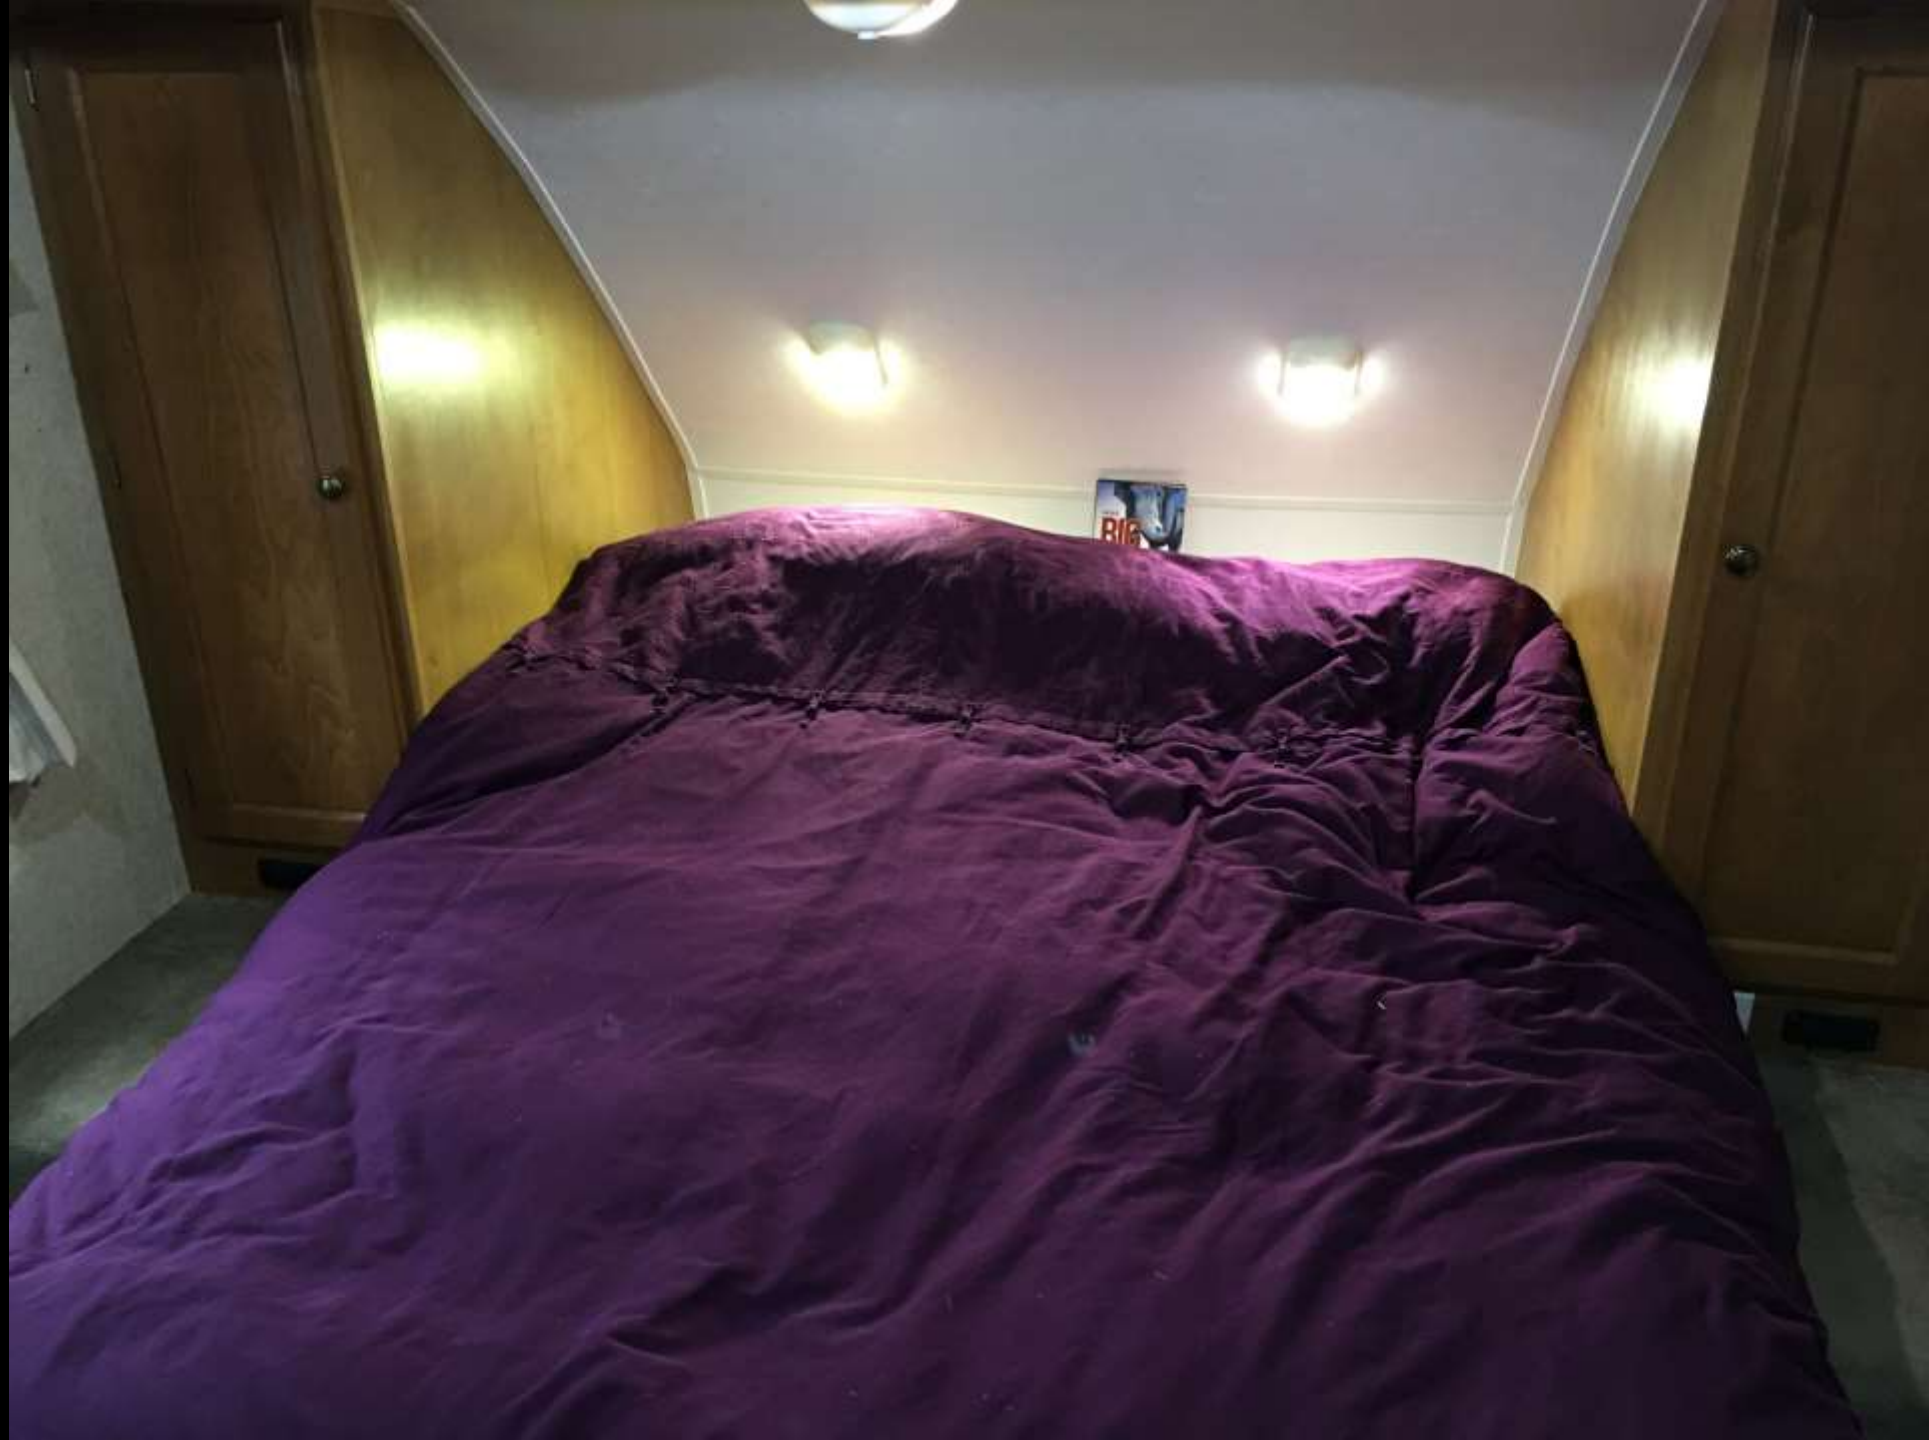
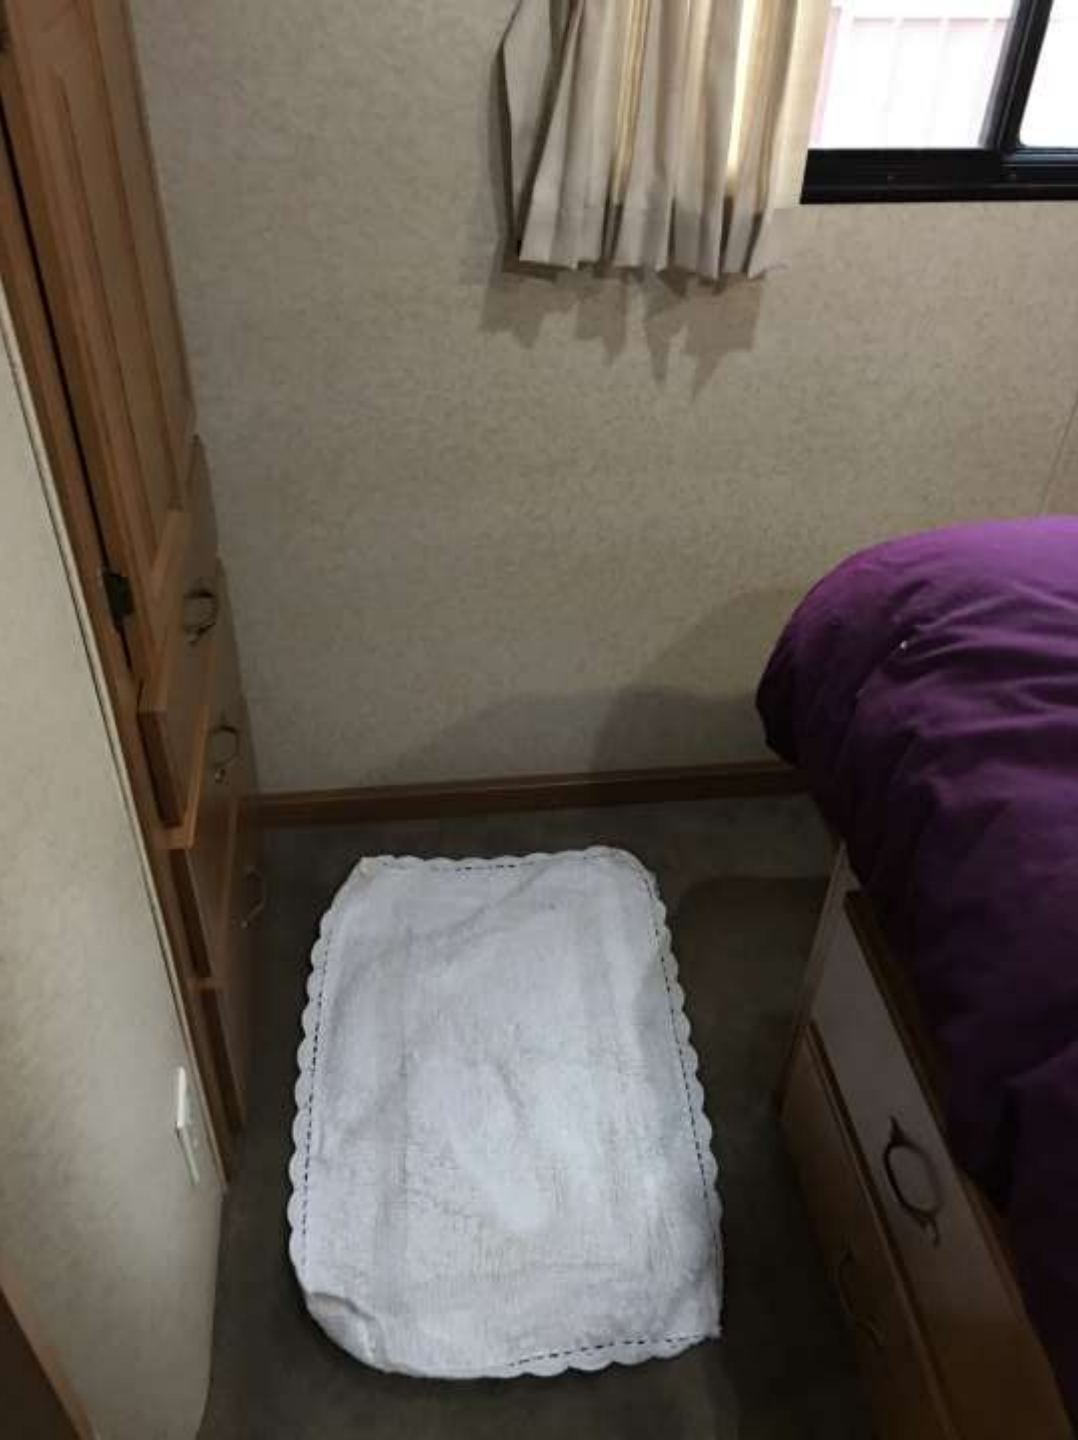
Dressing and  
Make up  
corners of  
the room.

So much  
room now,  
with the full  
length queen  
bed!

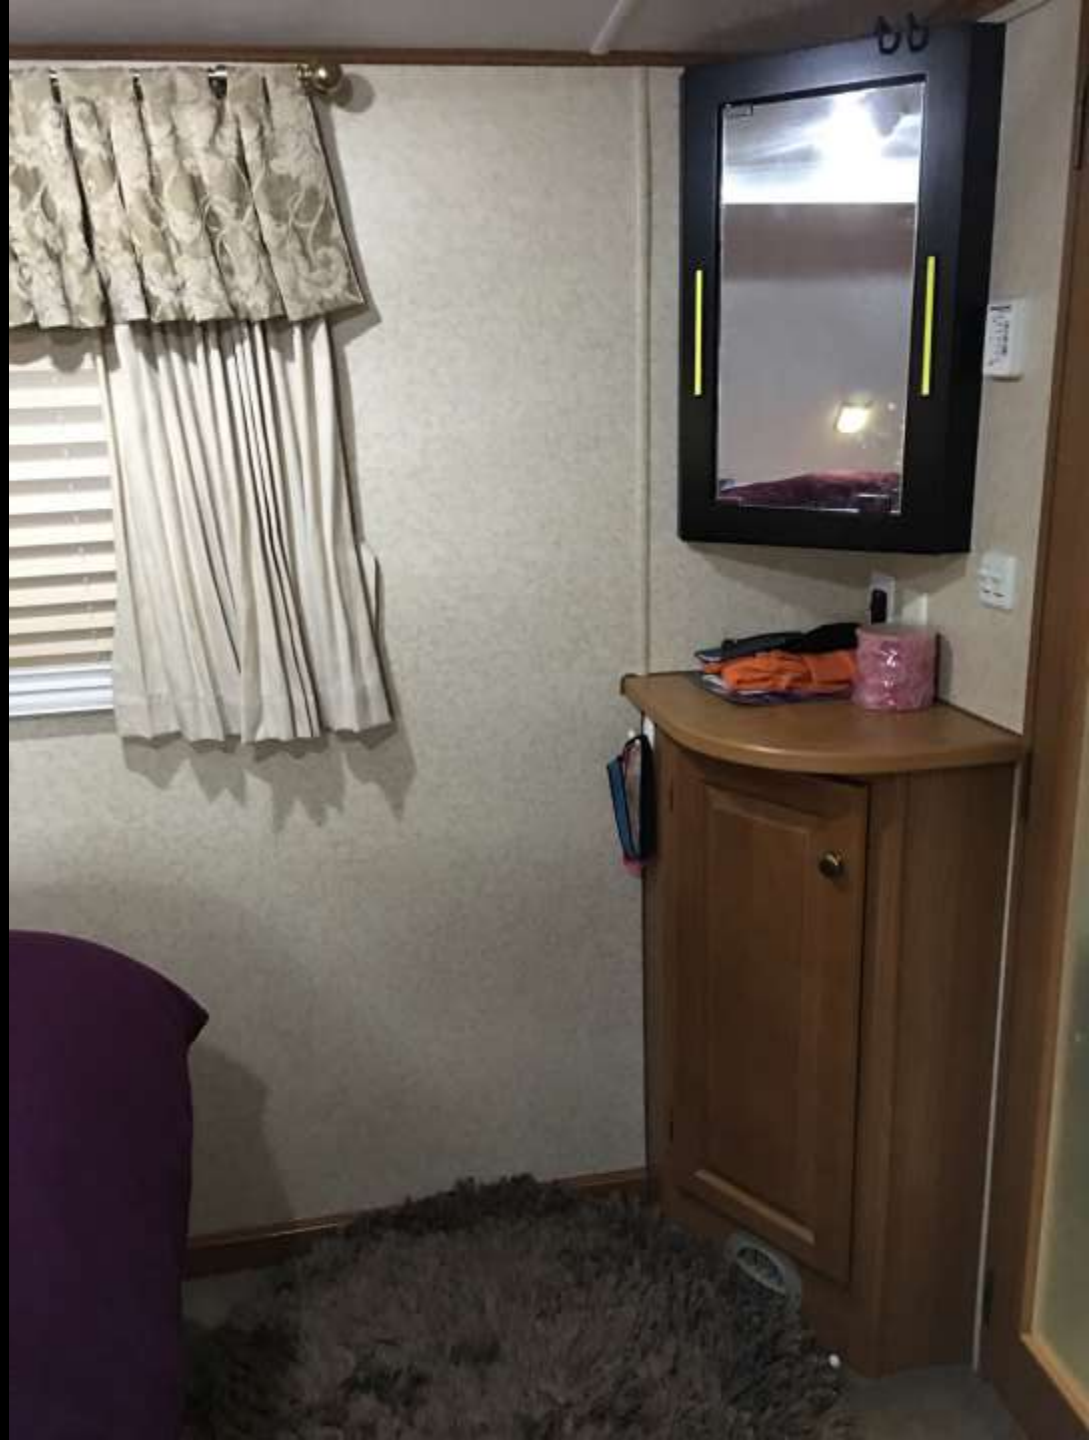
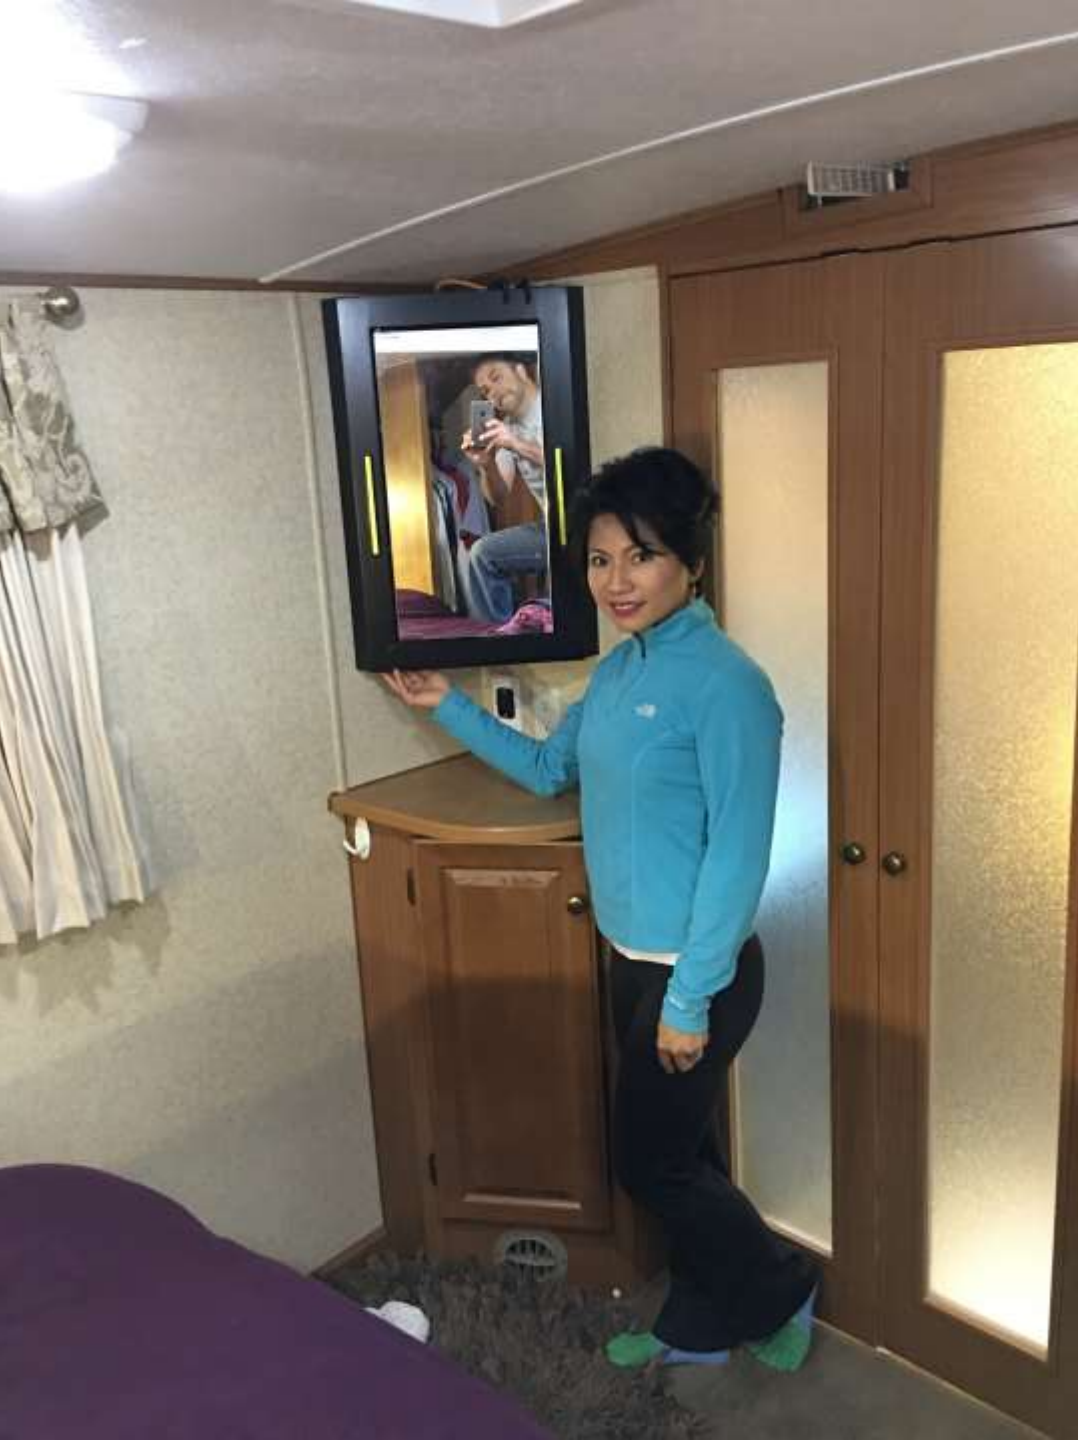
Make up  
area lights  
on, lights off.

Little LED  
Strips...

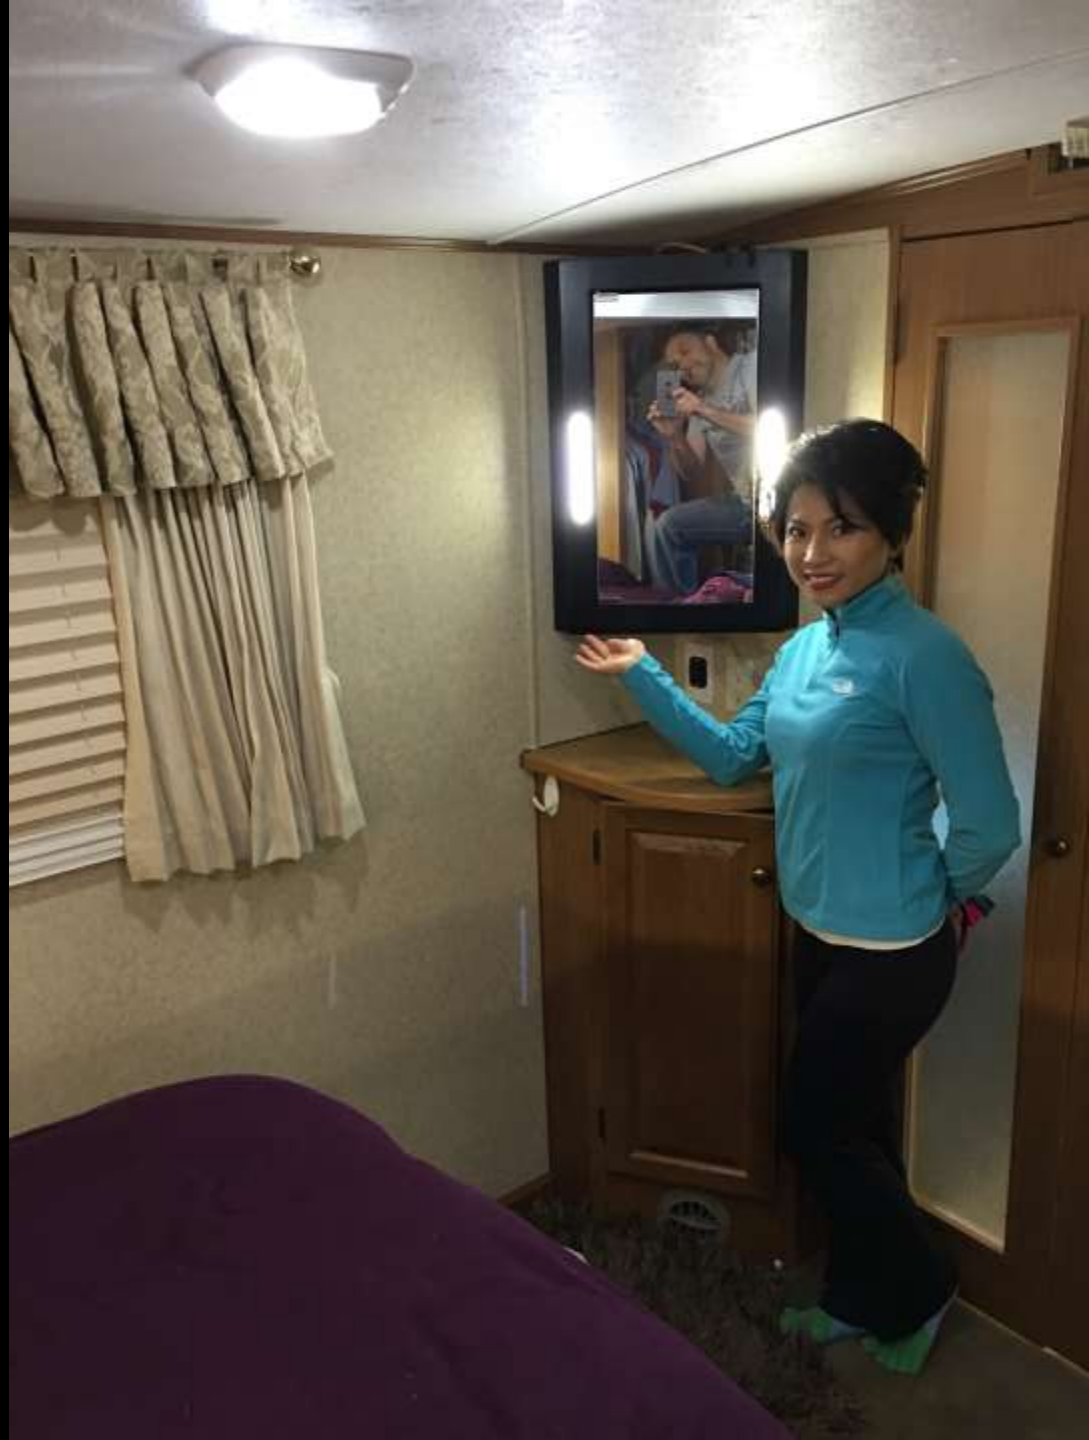
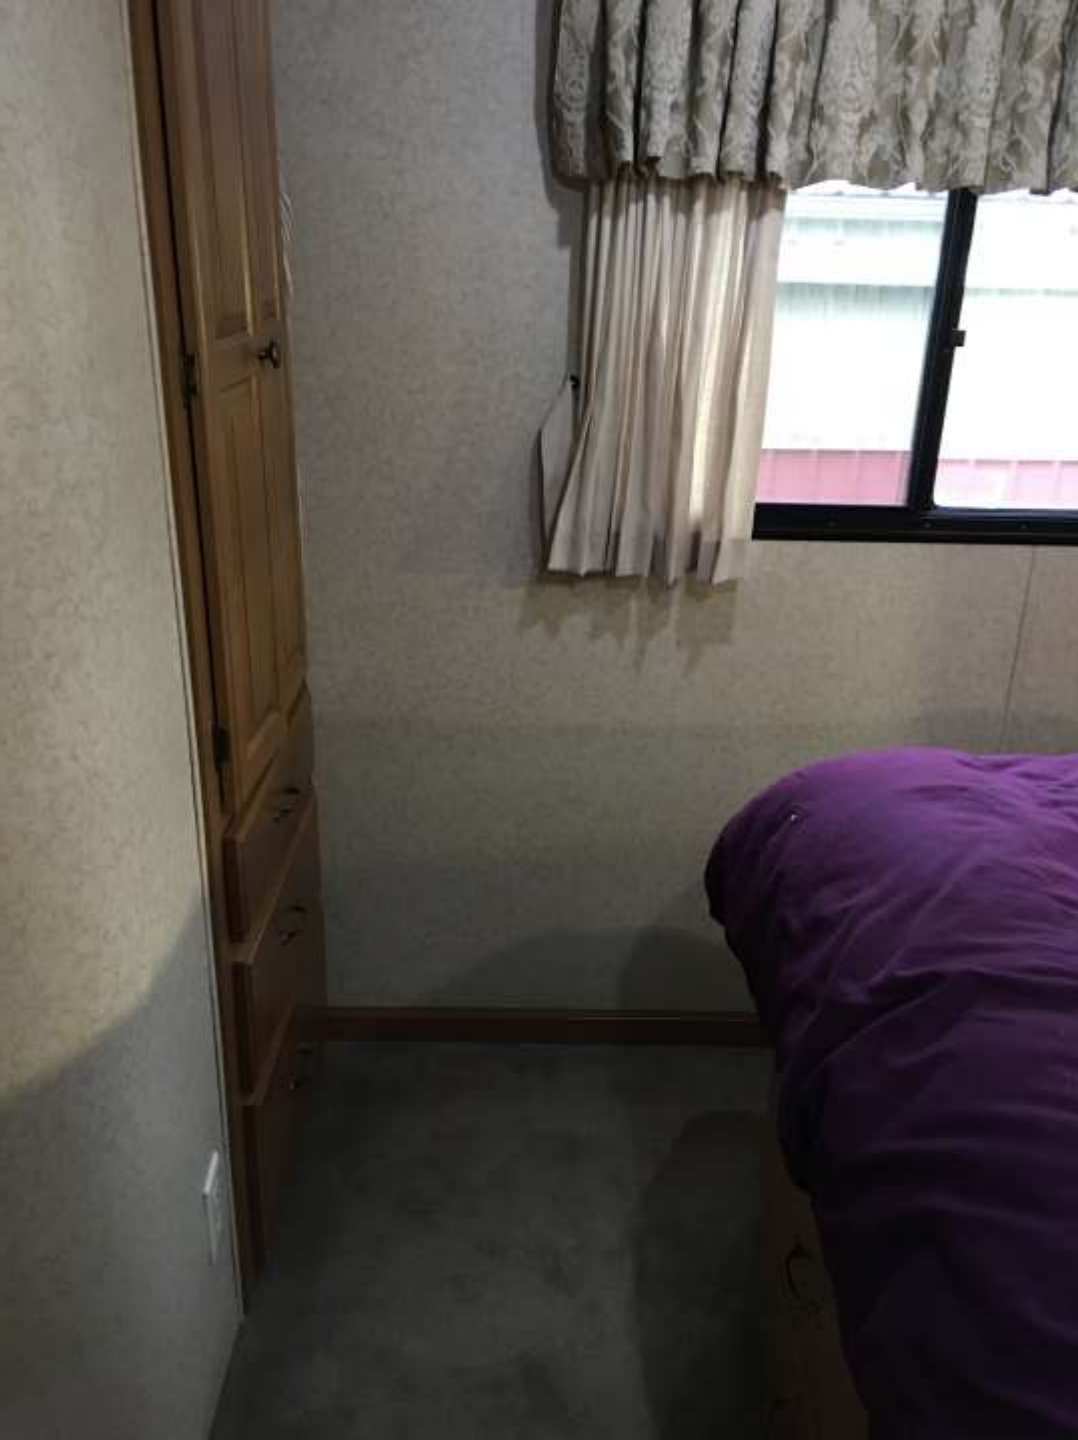
I took the “stile” out of the closet. So easier to access the clothes. It’s a great dressing area now! It was a cramped corner before.
